SALISBURY  
CITY COUNCIL

# WYNDHAM PARK WALLS

## SOLUTION PROPOSAL

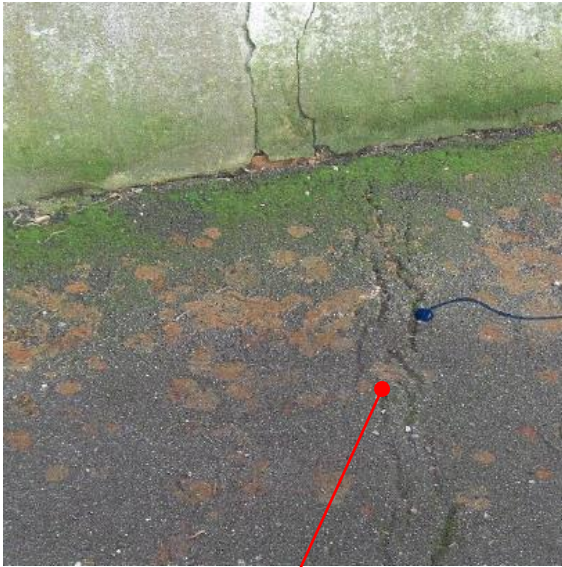
Damage to the footpath from tree roots.

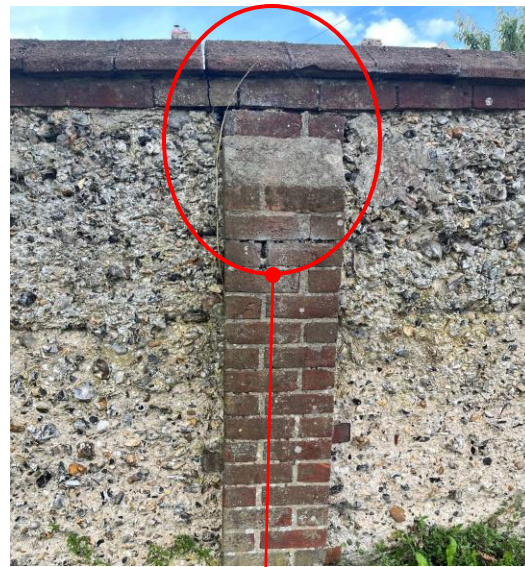
Cracking in brick pier.

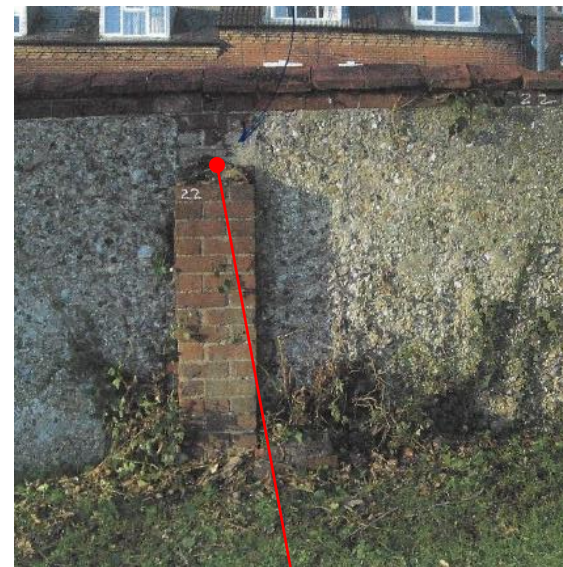
Top of pier is missing and weathering of the wall.

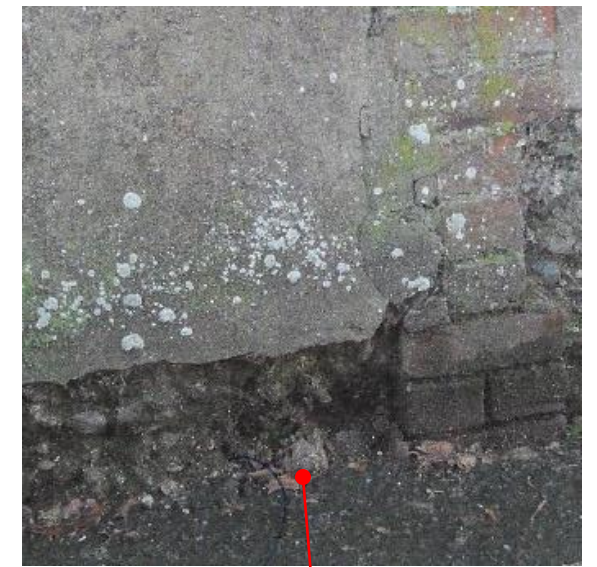
Loss of wall material at base.

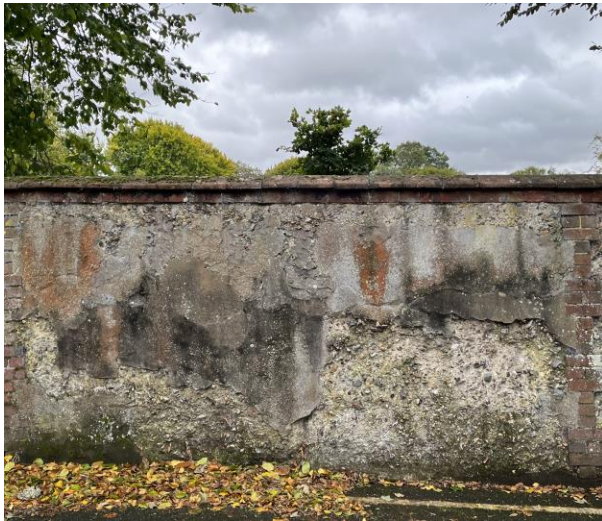
Wall 3

We assume the walls would have been rendered with a lime render. These walls have, in many cases, now been re-rendered in places with cement render, which is trapping moisture in the wall and, over the years, has caused damage to the wall's integrity.

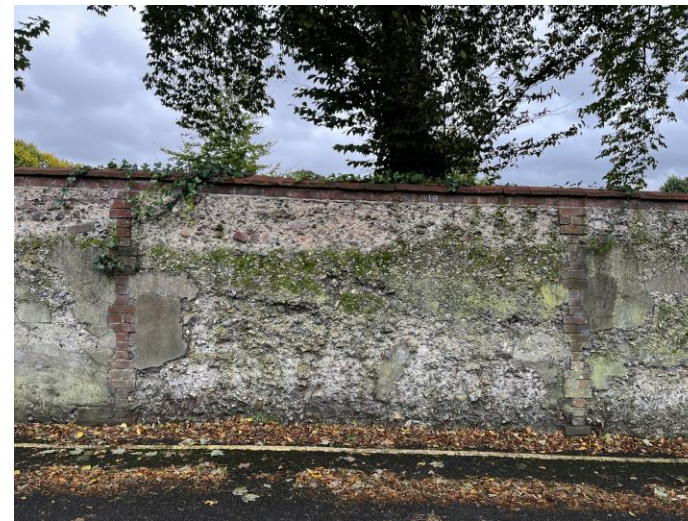
Wall 3

Local resident Spencer Hall, a Historic Building Specialist and Conservation Consultant, has carried out an analysis of the wall construction. His findings indicate that it is composed of chalk, flint, and a lime-based mortar. The lime strength appears to be either NHL 3.5 or NHL 5, depending on the proportion of chalk within the mix. Based on this, we propose using a blend of flint and flinty gravel with NHL 5, mixed at a ratio of 1 part binder to 4 parts aggregate.
