SALISBURY
CITY COUNCIL

Harnham Woodland

Report Objectives

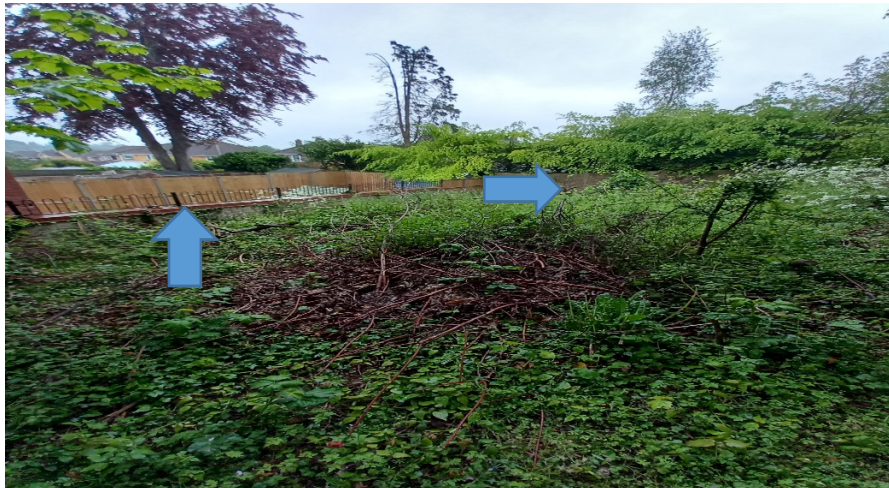
There is a retaining wall and steps leading from Bridgewater close and a further wall stretching across the neighbouring property. A wooden fence marks the boundary of the garden from a property at Montague road. A post and rail fence which is in poor condition runs across the grassed area in front of the woodland the whole width of Bridgewater close. An earth bank marks the boundary between the woodland and land behind the industrial estate.

Boundaries to residential properties at Bridgewater close and Montague road

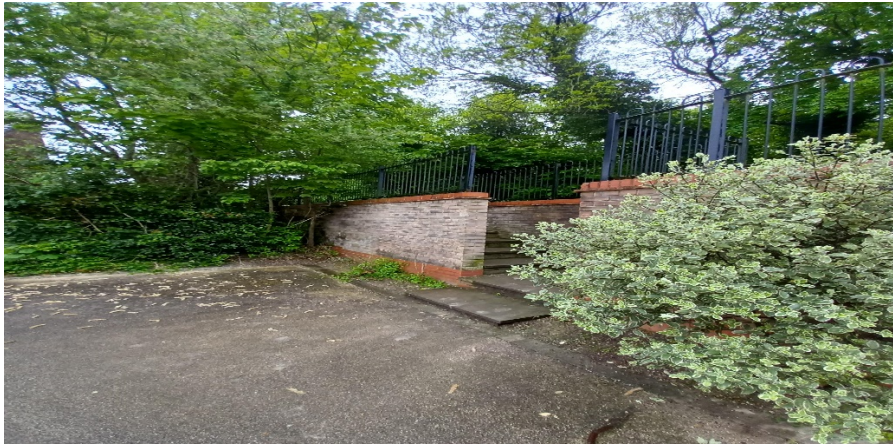
Boundary steps leading from Bridgewater close

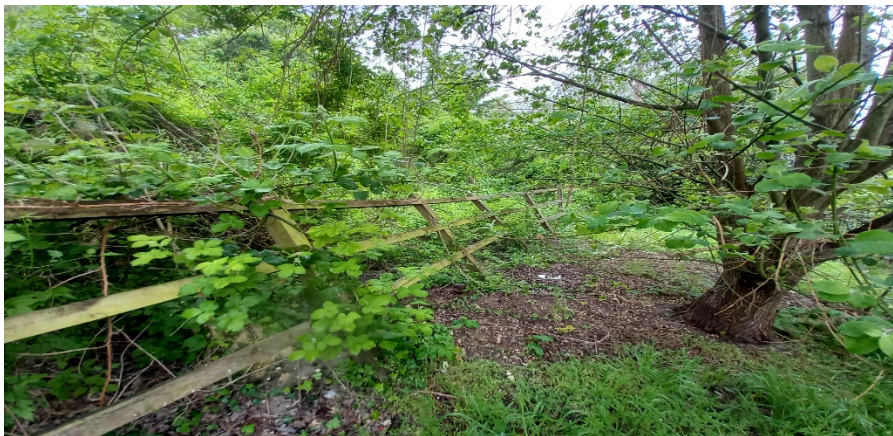
Boundary post and rail fence dividing the woods and residential land

The fence boundary between Bridewater Close and the woodland is in poor condition and has rails missing in places, it has completely collapsed on the western side.

Post and rail boundary fence

Element	Cost
Arboricultural work	£35,000.00
General site tidy/litterpick	£500
Post and rail boundary fencing and level entrance ground	£4500
Total	£40,000.00

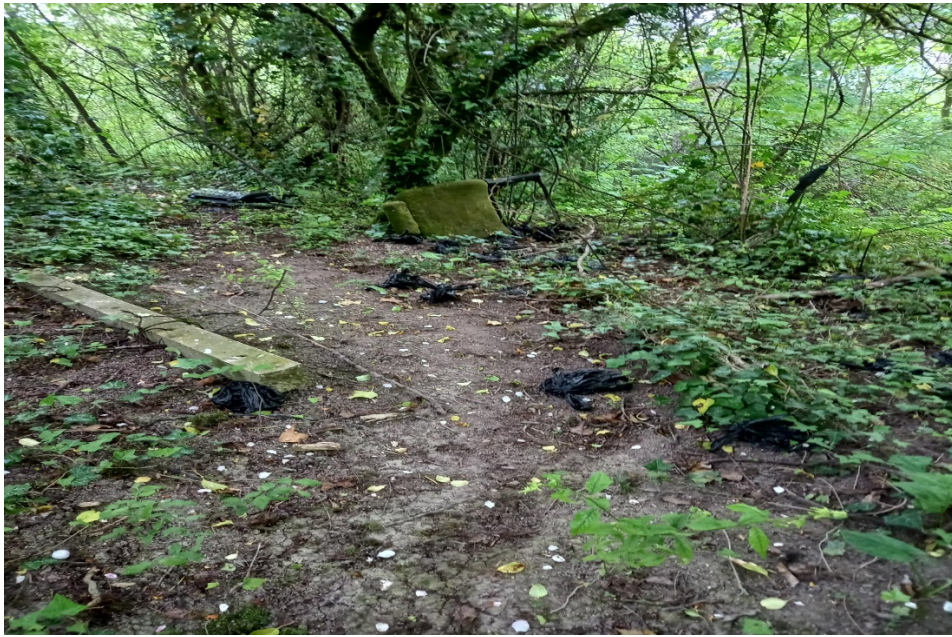
During the site visit there was evidence that the area is used by dog walkers with some dog foul in bags on the floor near the entrance. It would be advisable to consider a litter bin in this location, there are no bins currently at the woodland. Further into the woods there was some fly tipping, an old car seat and various other litter which looked as though it had been there for some time. Despite some rubbish being on site, generally, the path was free of dog foul and litter.

Fly tipping on the side of the path at the bottom of the slope

Flytipping needs to be removed and the area would benefit from a litterpick

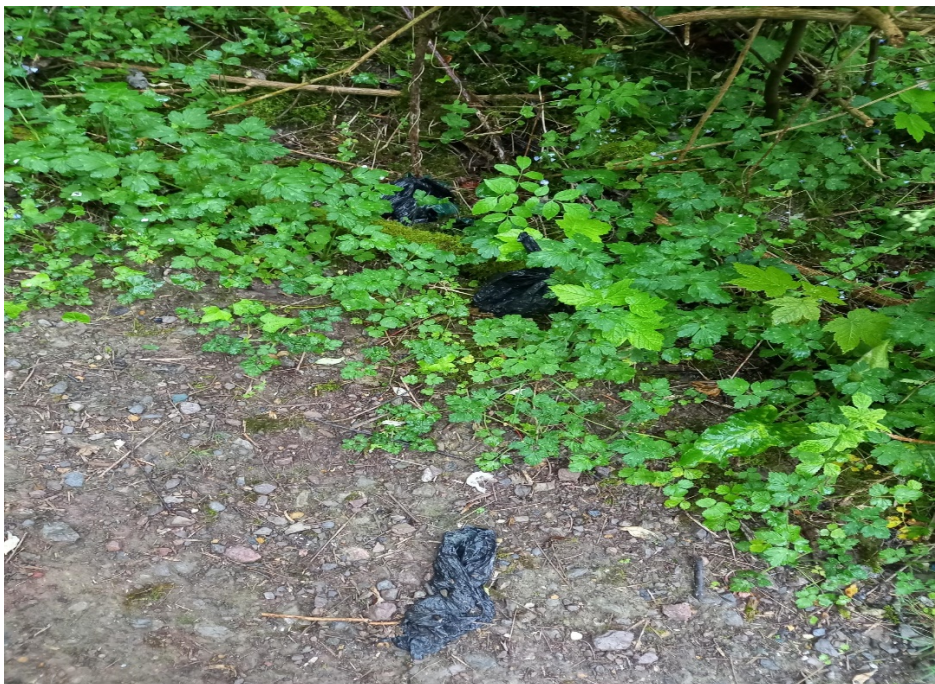
Dog bags by entrance from Bridgewater Close

Currently there are no litter bins installed on the site. It may be desirable to install a bin near the Bridgewater Close entrance where the site is frequently accessed. Knowing what the access rights from the estate will be vital before purchase. The bin would need to be emptied at least twice a week.

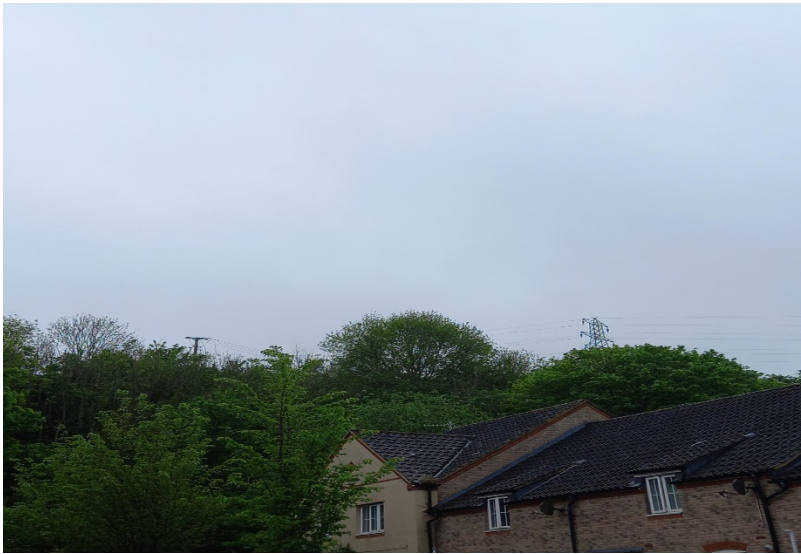
There is two sets of power cables which run from the back of the woodland at the top of the slope next to the farmer's field down to the trading estate. The cables currently seem free from trees and branches but could potentially need to be cleared in the future as the trees mature in size.

Two powerlines running above the woodland

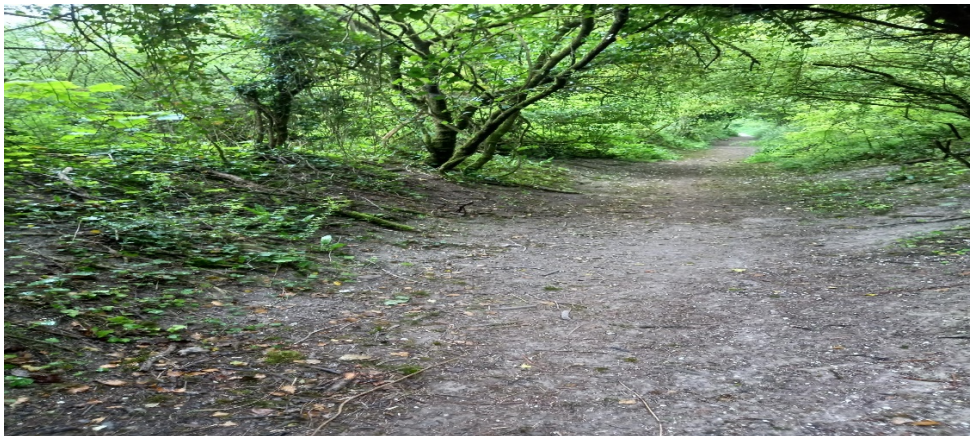
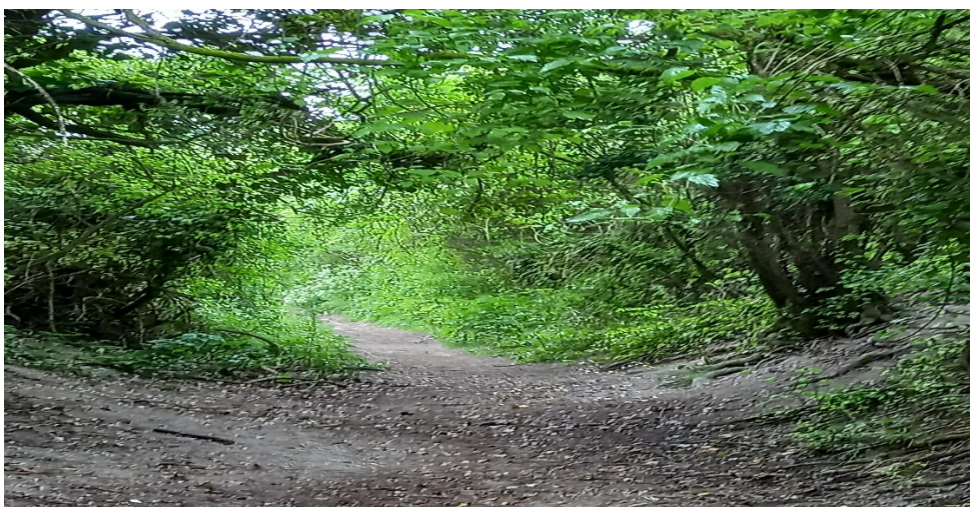
The woodland comprises of mainly Sycamore *Acer Pseudoplatanus* and Ash *Fraxinus* trees with the occasional Yew *Taxus Baccata* tree further up the slope. There is a dense thicket of Hawthorn and Blackthorn at the top of the slope providing a good habitat for wildlife. Unfortunately, Ash die back has taken hold on the majority of the Ash trees and they are badly affected by the disease. Most of these are close to the entrance from Bridgewater close and next to the path, so from a safety point of view they would need to be removed. The woodland is naturally regenerating young saplings but most of these are Sycamore so some tree planting may be required to introduce other species. There is an abundance of bird life in the area and signs that larger animals are present on the slope as there are lots of small trails leading off the path. Ferns such as *Asplenium Scolopendrium* grow on the woodland floor and Cow parsley *Anthriscus Sylvestris* grow on either side of the path giving a pleasant display of white flowers in early summer. The path consists of chalk and dirt and doesn't show any signs of needing additional attention.

The woodland path

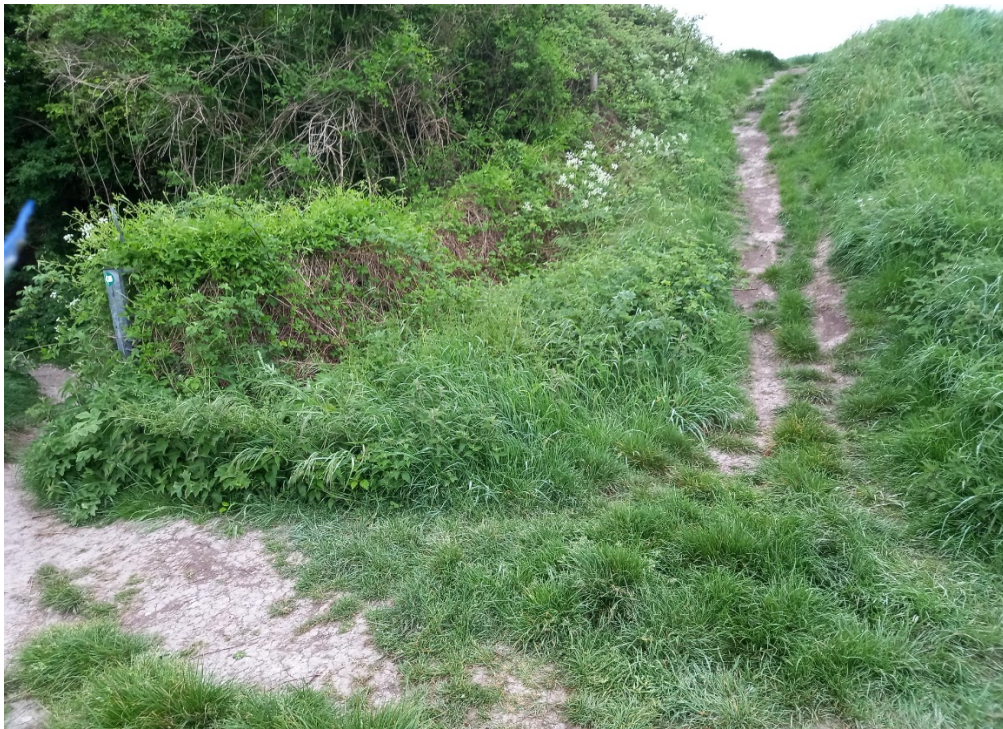
Desire path leading around the back of the woodland to the top of the slope
