Access Audit

Pinewood Way Play Area &
Folly Nature Reserve,
Pinewood Way, Salisbury

Prepared on Behalf of
Salisbury City Council

Date: 11th May 2023

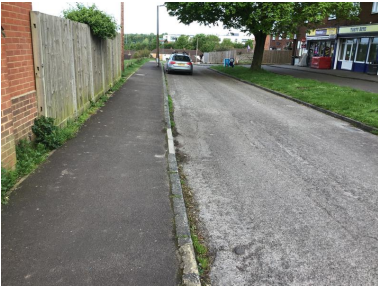
| Photo | Item | Issues | Recommendations | P | £ |
|--|---|---|--|---|---|
| | 1.2.1 | The pavement along the upper parts of Pinewood Way next to the playing field achieves an adequate width of 1200mm or more, is set to an acceptable gradient and has a firm and level surface. | | | |

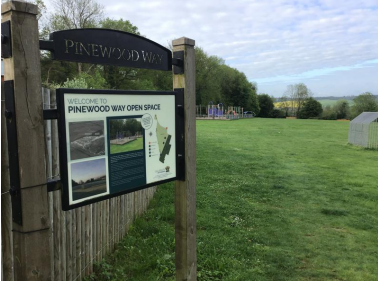
| Photo | Item | Issues | Recommendations | P | £ |
|--|---|---|--|---|---|
| | 1.2.2 | Clear well contrasting signage is provided at the entrance into the playing field. A simple site map is provided. | | | |

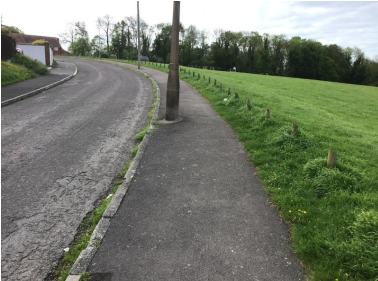
| Photo | Item | Issues | Recommendations | P | £ |
|--|---|---|--|---|---|
| | 1.2.3 | The approach from the lower parts of Pinewood Way is set at a gradient exceeding 1:12 which will make it very difficult to negotiate by a manual wheelchair user in particular. | Inform users of steep approach in advance i.e. website, access guide etc | 2 | Zero |
| | | However as the gradient is consistent with surrounding ground levels there is little practical alteration other than to make users aware in advance and advise of alternative routes, if there are any. | | | |

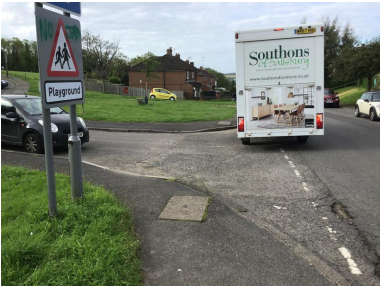
| Photo | Item | Issues | Recommendations | P | £ |
|--|---|--|--|---|---|
| | 1.2.4 | The dropped kerb point at the junction of Pinewood Way with Westwood Road has no tactile blister paving fitted and thus there is a risk that visually impaired users will walk into the carriageway unawares. | Fit tactile 'blister' profile paving to crossing point | 2 | Zero |

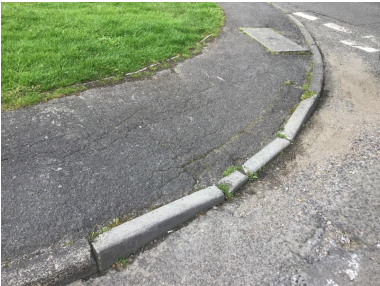
| Photo | Item | Issues | Recommendations | P | £ |
|--|---|--|--|---|---|
| | 1.2.5 | The dropped kerb point has an excessive upstand at the carriageway edge making it difficult to mount by a wheelchair user. Best practice recommends a maximum upstand of 6mm when using a bullnose kerb. | Lower drop kerb to sit flush with carriageway | 2 | Zero |

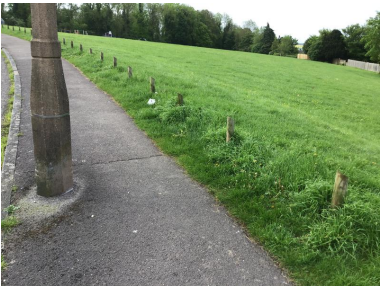
| Photo | Item | Issues | Recommendations | P | £ |
|--|---|--|--|---|---|
| | 1.2.6 | The bollards and street lighting are poorly contrasted to their surroundings and thus a visually impaired person will be at risk of collision. Contrasting bands of at least 150mm in depth should be applied at 1500mm above ground level and around the head of the bollards. | Apply contrasting markings to street furniture | 2 | Zero |

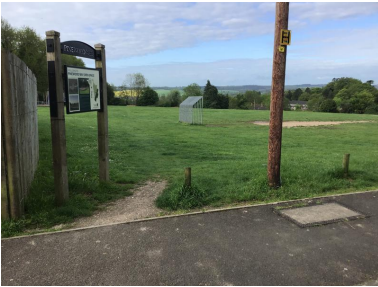
| Photo | Item | Issues | Recommendations | P | £ |
|--|---|--|---|---|---|
| | 1.2.7 | The pavement provides direct access onto the main playing field. | | | |

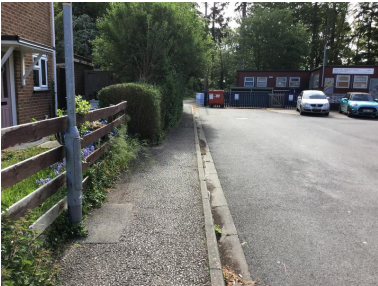
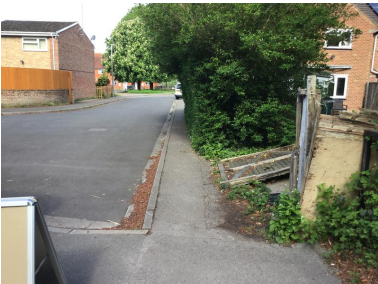
| Photo | Item | Issues | Recommendations | P | £ |
|--|---|--|---|---|---|
| | 1.2.8 | Vegetation obstructs the pavement reducing the clear width to as little as 600mm along the route to the Bemerton Folly, making it difficult to pass by a wheelchair, crutch or frame user. | Cut back vegetation to achieve a minimum clear width of 900mm | 2 | Zero |

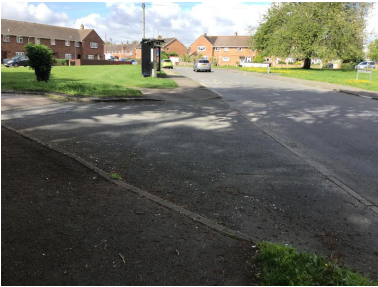
| Photo | Item | Issues | Recommendations | P | £ |
|---|---|---|---|---|---|
| | 1.2.9 | <p>The dropped kerb point at the junction of Pinewood Way with Folly View has no tactile blister paving fitted and thus there is a risk that visually impaired users will walk into the carriageway unawares.</p> | <p>Fit tactile 'blister' profile paving to crossing point</p> | 2 | Zero |

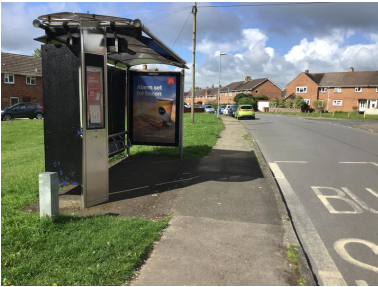
| Photo | Item | Issues | Recommendations | P | £ |
|---|---|---|---|---|---|
| | 1.2.10 | <p>Bus stops are located along Pinewood Way within 200m of the Folly entrance. Ideally they would added to your Access Guide.</p> | | | |

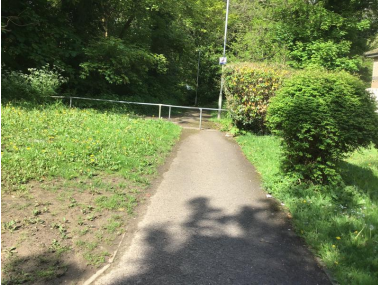
| Photo | Item | Issues | Recommendations | P | £ |
|---|---|---|---|---|---|
| | 1.3.1 | <p>The approach to The Folly from Bernards Hill Drive is set at a gradient exceeding 1:12 which will make it very difficult to negotiate by a manual wheelchair user in particular.</p> | <p>Inform users of steep approach in advance i.e. website, access guide etc</p> | 2 | Zero |
| | | <p>However as the gradient is consistent with surrounding ground levels there is little practical alteration other than to make users aware in advance and advise of alternative routes, if there are any.</p> | | | |

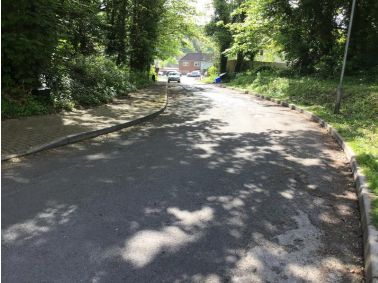
| Photo | Item | Issues | Recommendations | P | £ |
|--|---|---|---|---|---|
| | 1.3.2 | <p>In this case it would be the approach from Pinewood Way.</p> <p>The approach from Bernards Hill Drive is set at a gradient exceeding 1:12 which will make it very difficult to negotiate by a manual wheelchair user in particular.</p> <p>However as the gradient is consistent with surrounding ground levels there is little practical alteration other than to make users aware in advance and advise of alternative routes, if there are any.</p> | <p>Inform users of steep approach in advance i.e. website, access guide etc</p> | 2 | Zero |

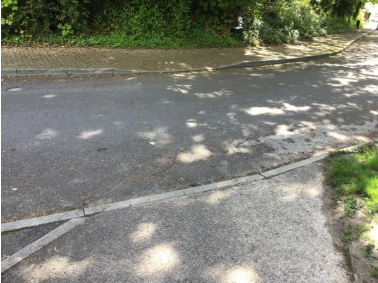
| Photo | Item | Issues | Recommendations | P | £ |
|--|---|---|---|---|---|
| | 1.3.3 | <p>In this case it would be the approach from Pinewood Way.</p> <p>The dropped kerb point at the top of Bernards Hill Drive has no tactile blister paving fitted and thus there is a risk that visually impaired users will walk into the carriageway unawares.</p> | <p>Fit tactile 'blister' profile paving to crossing point</p> | 2 | Zero |

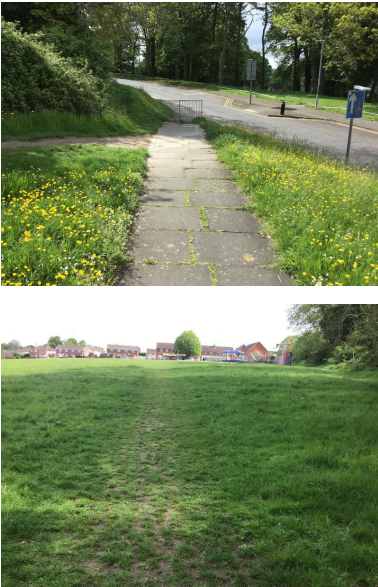
| Photo | Item | Issues | Recommendations | P | £ |
|---|---|--|---|---|---|
| | 1.4.1 | <p>The approach to the park from Westfield Road is set at a gradient exceeding 1:12 which will make it very difficult to negotiate by a manual wheelchair user in particular.</p> <p>However as the gradient is consistent with surrounding ground levels there is little practical alteration other than to make users aware in advance and advise of alternative routes, if there are any.</p> | <p>Inform users of steep approach in advance i.e. website, access guide etc</p> | 2 | Zero |

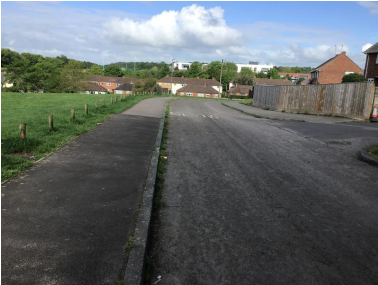
| Photo | Item | Issues | Recommendations | P | £ |
|---|---|---|--|---|---|
| | 2.1 | <p>There is no parking on site and no feasible means to provide any. We suggest you establish the nearest public accessible parking and add its location to your visitor information.</p> | | | |

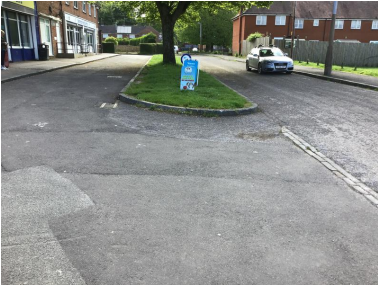
| Photo | Item | Issues | Recommendations | P | £ |
|---|---|---|--|---|---|
| | 2.2 | <p>A small parking area is located next to the local shops and Bremerton Health Centre.</p> | | | |

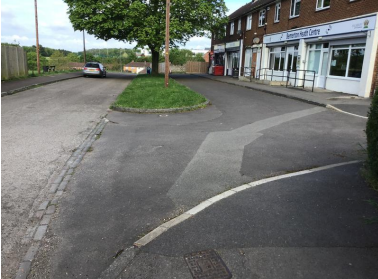
| Photo | Item | Issues | Recommendations | P | £ |
|---|---|---|--|---|---|
| | 2.3 | <p>We recommend you request that an accessible parking bay is designated.</p> <p>An on-street accessible parking space would enable disabled drivers to use the park and facilities opposite Pinewood Way as well as the Folly.</p> | <p>Request an on-street accessible parking space</p> | 2 | Zero |

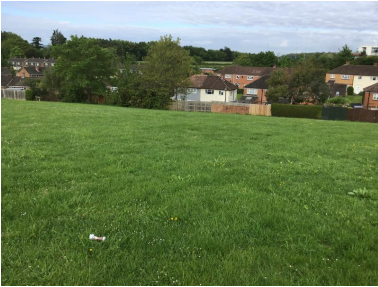
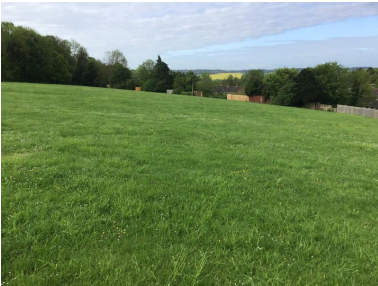
| Photo | Item | Issues | Recommendations | P | £ |
|---|---|--|--|---|---|
| | 4.1.1 | <p>The field slopes downward from Pinewood Way to the west and is set to a gradient exceeding 1:20 which will make it very difficult to negotiate by a manual wheelchair user in particular.</p> <p>However as the gradient is consistent with surrounding ground levels there is little practical alteration other than to make users aware in advance.</p> | | | |

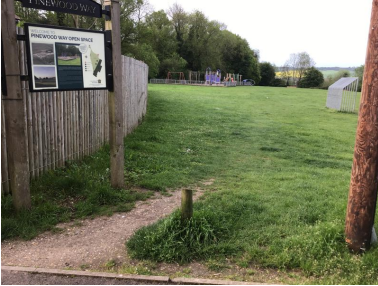
| Photo | Item | Issues | Recommendations | P | £ |
|---|---|--|--|---|---|
| | 4.2.1 | <p>The is no metaled path serving the play area and basket ball hard court making this area very difficult to access by a wheelchair user.</p> <p>The soft grass will pose a barrier to a wheelchair or mobility impaired user.</p> <p>We recommend that a new pathway is</p> | <p>Form path to link play area with approach from Pinewood Way</p> | 3R | E |

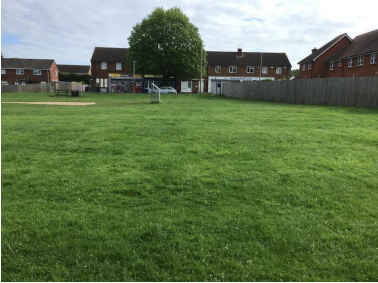
| Photo | Item | Issues | Recommendations | P | £ |
|--|---|---|--|---|---|
| | 4.3 | <p>provided from the park entrance opposite the Bremerton Health Centre to the play area and basket ball court across the upper part of the park which is reasonably level.</p> <p>The pathway should ideally achieve a minimum width of 1800mm with rest opportunities at intervals of not less than 50m.</p> | | | |

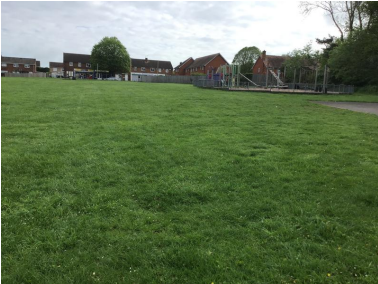
| Photo | Item | Issues | Recommendations | P | £ |
|--|---|---|--|---|---|
| | 4.3.1 | <p>Outdoor Seating</p> <p>There is limited seating in the park which may pose a barrier to an elderly or mobility impaired person who may need to take rest breaks at regular intervals.</p> <p>Along the new principal pathway route we suggest additional seating is installed to achieve seating opportunities at maximum 50 metre intervals.</p> <p>Best practice recommends that a range of seating be provided but we suggest that around 50% of seating should be set at a height of 450-480mm with back and armrests which will provide a useful means of leverage for an elderly or mobility impaired person.</p> <p>This will allow disabled users a view over</p> | <p>Install additional seating along new pathway to achieve seating opportunities at max. 50m intervals</p> | 3R | Inc above |

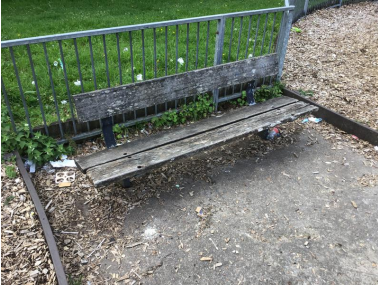
| Photo | Item | Issues | Recommendations | P | £ |
|---|---|---|---|---|---|
| | 4.3.2 | <p>the lower areas of the park and beyond as well as the play area.</p> <p>The existing outdoor seating is poorly contrasted against their background making them more difficult to discern by a visually impaired user posing a risk of collision.</p> | <p>Improve contrast of outside seating when redecorating</p> | 3R | Zero |

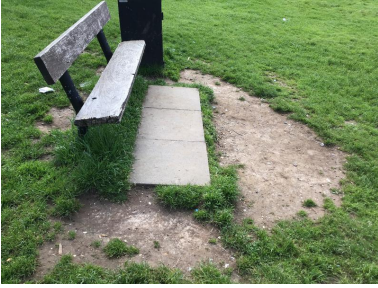
| Photo | Item | Issues | Recommendations | P | £ |
|---|---|---|---|---|---|
| | 4.3.3 | <p>The seating does not have any armrests making it more difficult for an elderly or mobility impaired person to get into and out of the seat due to a lack of leverage.</p> | <p>Install new seating with back and armrests when updating seating</p> | 3R | Zero |

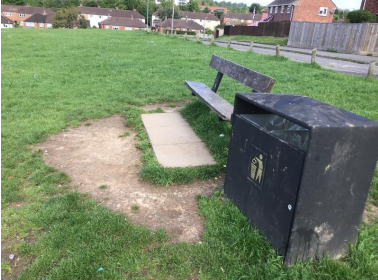
| Photo | Item | Issues | Recommendations | P | £ |
|---|---|---|---|---|---|
| | 4.3.4 | <p>There is no space alongside the benches for a wheelchair user to sit alongside his or her companion.</p> | <p>Extend paving to provide hard surface for wheelchair user to sit alongside</p> | 2 | A |

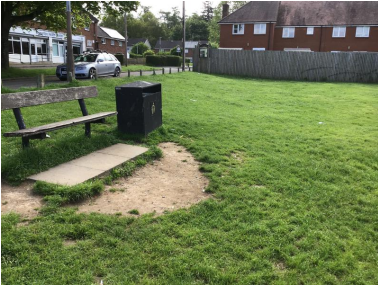
| Photo | Item | Issues | Recommendations | P | £ |
|---|---|--|--|---|---|
| | 4.3.5 | The is no metaled path serving the seating making this area very difficult to access by a wheelchair user. | Move seating at Pinewood Road onto metaled area or form path to link seating to hard surfaced area | 2 | A |

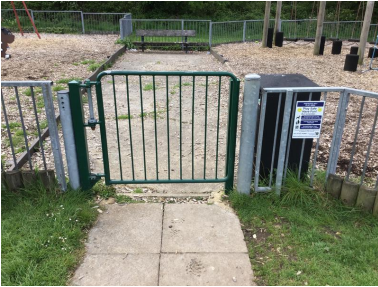
| Photo | Item | Issues | Recommendations | P | £ |
|--|---|---|--|---|---|
| | 5.1.1 | The entrance gate achieves a clear width of 900mm which exceeds current best practice standards so should be sufficient for all. | | | |

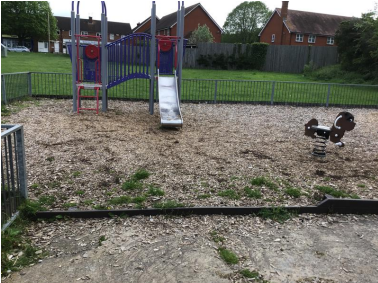
| Photo | Item | Issues | Recommendations | P | £ |
|--|---|---|--|---|---|
| | 5.2.1 | There is no dropped kerb at the raised play areas to the side of the central hard surfaced pathway and thus it will be very difficult for a wheelchair user to transfer onto the play areas to participate or assist a child. | Re-grade levels each side of raised play area from central pathway | 2 | A |

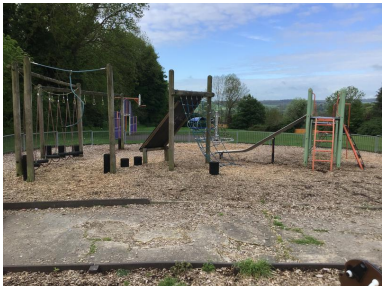
| Photo | Item | Issues | Recommendations | P | £ |
|---|---|--|--|---|---|
| | 5.2.2 | <p>The loose particle surface to the Play Areas will be very difficult to pass by a wheelchair user as the wheels of a chair will bind with the loose particles.</p> <p>At the time of refurbishment we recommend that play area is resurfaced with a rubber playground safety flooring system to the equipment for younger children and to accessible play equipment.</p> | Re-surface play area with a rubber playground safety flooring system | 3R | D |

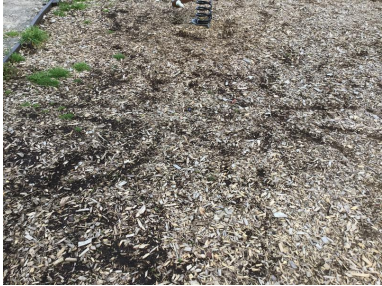
| Photo | Item | Issues | Recommendations | P | £ |
|---|---|--|--|---|---|
| | 5.2.3 | In the short term we recommend that you regularly roll in loose particles and regularly maintain these area | Roll in loose particles and regularly maintain area | 3M | A |

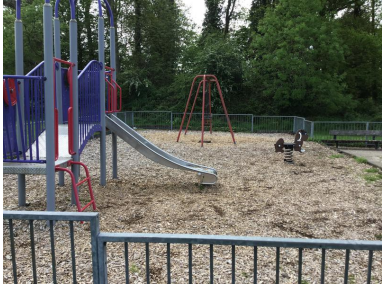
| Photo | Item | Issues | Recommendations | P | £ |
|---|---|--|--|---|---|
| | 5.3.1 | <p>5.3 Play Equipment</p> <p>None of the play equipment to play areas affords level access for a wheelchair using child such as a level access roundabout.</p> | Install level access play equipment | 3R | B |

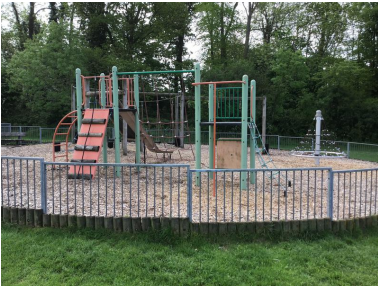
| Photo | Item | Issues | Recommendations | P | £ |
|---|---|--|--|---|---|
| | 5.3.2 | Ideally play equipment should provide both visual and audio stimulation. This is not the case to the play areas here. | Introduce some play equipment which provides audio stimulation | 3R | A |

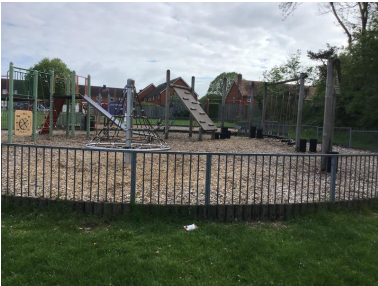
| Photo | Item | Issues | Recommendations | P | £ |
|---|---|--|--|---|---|
| | 5.3.3 | Play equipment should be provided at a range of levels and this allows for challenging play for a range of abilities including children with mobility impairments. | Equipment to play area is set over various levels and considering the size of the park caters for a range of age groups and abilities. | | |

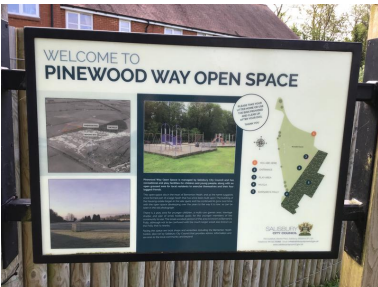
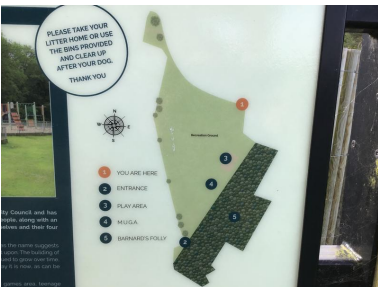
6.1.1 The park is fitted with a clear well contrasting wayfinding signage scheme.

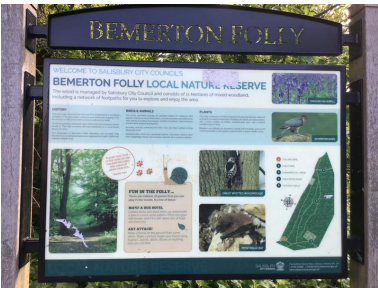
The Folly is fitted with a clear well

| Photo | Item | Issues | Recommendations | P | £ |
|---|---|--|--|---|---|
| | | <p>contrasting wayfinding signage scheme at the entrance. The primary routes through the Folly are identified.</p> <p>We recommend that the plan is further developed and updated to reflect the gradients where they pose a barrier to a disabled user.</p> <p>We recommend that gradients exceeding 1:20 are identified and that the more severe gradients exceeding 1:12 are identified in a contrasting colour and/or with differing gradient symbols.</p> <p>Considering the setting, we recommend that you identify the more accessible tarmac or hard surfaced principal pathways through the park and the primary unmade compacted earth pathways.</p> | | | |

Develop site plan to identify steep gradients and primary pathway surfaces

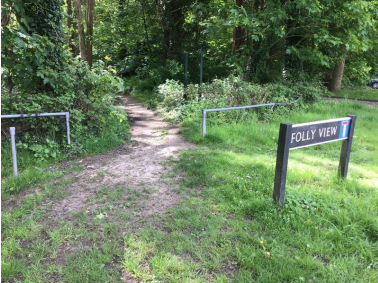
| Photo | Item | Issues | Recommendations | P | £ |
|---|---|--|--|---|---|
| | 6.2.3 | <p>The signage or markers should be coordinated with the site map.</p> <p>The signage at the Folly View entrance has been removed. We recommend that you reinstate Folly entrance signage at Folly View and provide signage at each principal entrance into the Folly.</p> | Provide signage at each principal entrance | 2 | B |

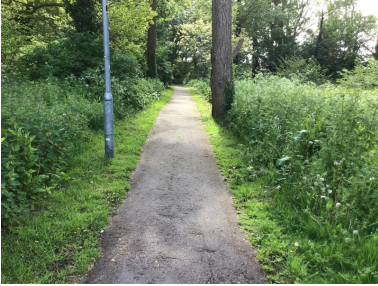
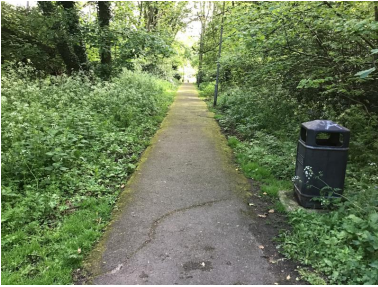
| Photo | Item | Issues | Recommendations | P | £ |
|---|---|--|---|---|---|
| | 7.1.1 | <p>The from the Pinewood Way entrance, the principal pathway through Folly achieves an adequate width of 1200mm or more, is set to an acceptable gradient and has a firm and level surface.</p> <p>This will allow all users to access a reasonable proportion of the Folly.</p> | | | |

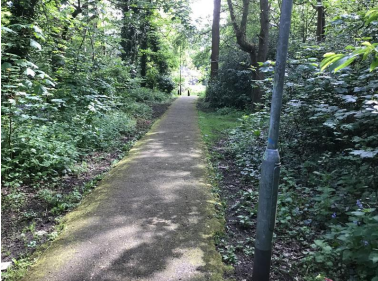
| Photo | Item | Issues | Recommendations | P | £ |
|---|---|--|---|---|---|
| | 7.1.2 | <p>Whilst our inspection was not completed at night we find it likely, based on the type and number of fittings, that the primary routes are well illuminated by street lighting.</p> | | | |

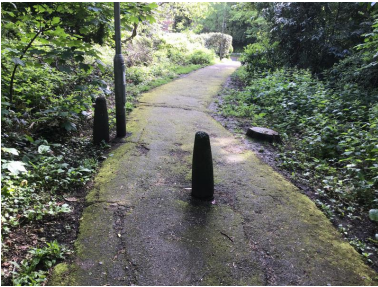
| Photo | Item | Issues | Recommendations | P | £ |
|---|---|---|--|---|---|
| | 7.1.3 | <p>The bollards and street lighting are poorly contrasted to their surroundings and thus a visually impaired person will be at risk of collision.</p> <p>Contrasting bands of at least 150mm in depth should be applied at 1500mm above ground level and around the head of the bollards.</p> | <p>Apply contrasting markings to pathway furniture</p> | 1 | A |

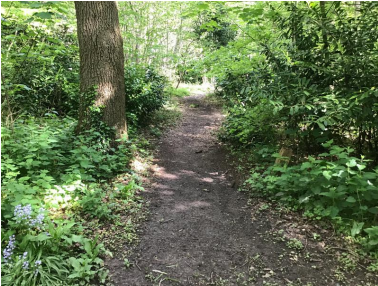
| Photo | Item | Issues | Recommendations | P | £ |
|---|---|---|--|---|---|
| | 7.1.4 | <p>The secondary pathways into the Folly woods consist of compacted earth making these areas very difficult to access by a wheelchair user, crutch or frame user.</p> <p>However considering the natural setting we would not consider it reasonable to widen and resurface the secondary pathways.</p> <p>The footpaths are as narrow as 600mm and some set to a gradient exceeding 1:20 making them difficult to use by a wheelchair user.</p> <p>In this instance there is no practical solution other than to ensure users are aware of this potential barrier in advance and can choose an alternative route. This</p> | | | |

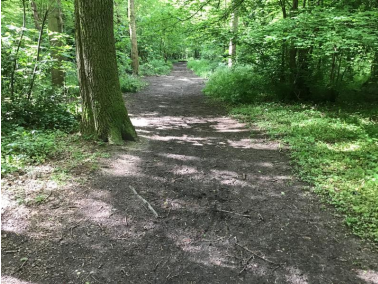
| Photo | Item | Issues | Recommendations | P | £ |
|---|---|---|--|---|---|
| | 7.1.5 | <p>is best dealt with by producing a well detailed map.</p> <p>The primary unmade pathways through the Folly, in general achieve an adequate width and acceptable gradient.</p> | | | |

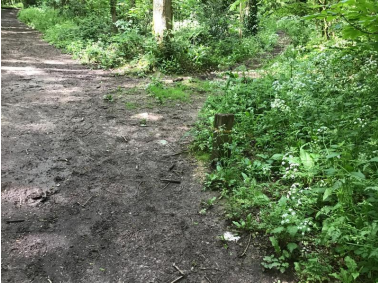
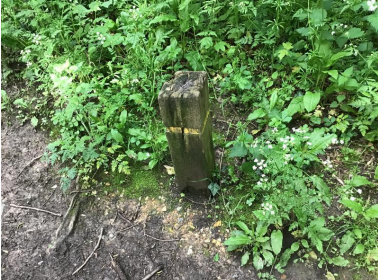
| Photo | Item | Issues | Recommendations | P | £ |
|---|---|---|--|---|---|
| | 7.1.6 | <p>The existing markers along pathways are obscured by vegetation.</p> | <p>Cut back vegetation to existing pathway markers</p> | 3M | A |

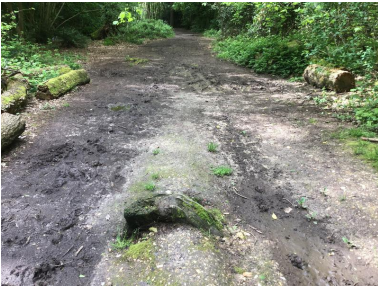
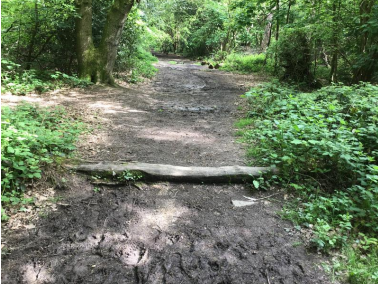
| Photo | Item | Issues | Recommendations | P | £ |
|--|---|---|--|---|---|
| | 7.1.7 | <p>Some of the unmade primary pathways through the Folly have significant obstructions blocking the routes.</p> <p>The logs and large obstructions should be removed.</p> | Remove large obstructions along key routes | 3M | B |

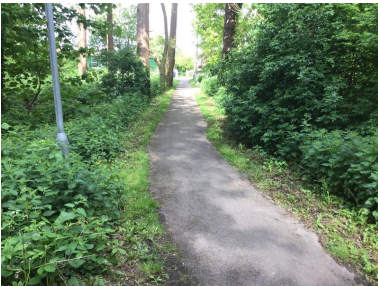
| Photo | Item | Issues | Recommendations | P | £ |
|--|---|---|--|---|---|
| | 7.1.8 | <p>There is little is any seating on the primary routes through the Folly which may pose a barrier to an elderly or mobility impaired person who may need to take rest breaks at regular intervals.</p> <p>We suggest additional seating is installed to achieve seating opportunities at maximum 100 metre intervals.</p> <p>Best practice recommends that a range of seating be provided but we suggest that around 50% of seating should be set at a height of 450-480mm with back and</p> | Install additional seating to achieve seating opportunities at max. 100m intervals along tarmac pathways | 2 | C |
