Proposed Conservation & Repair: The Poultry Cross Project Summary

Salisbury City Council

Report to the City Council

The Poultry Cross: Phase I Repairs

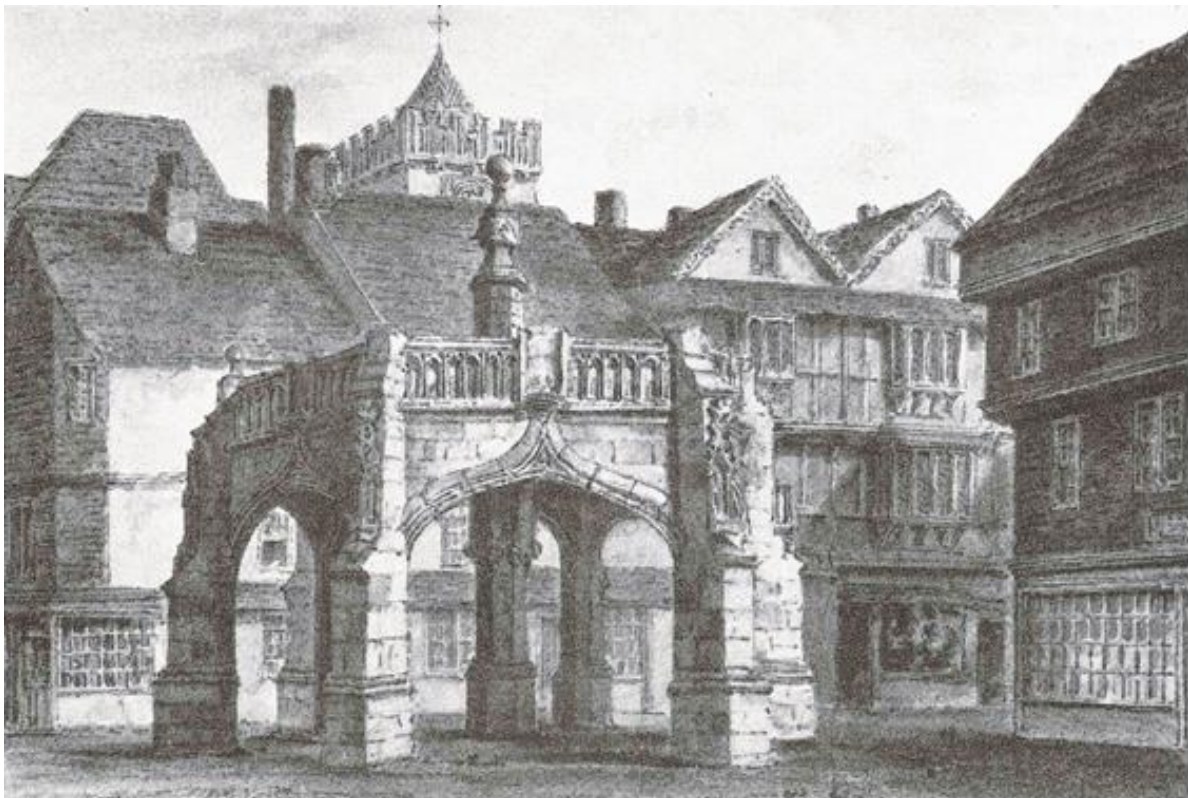
Fig 3: Poultry Cross, 1810, Water colour by J Buckler (Devises Museum)¹

The Poultry Cross before the high level alterations and flying buttress additions of 1852

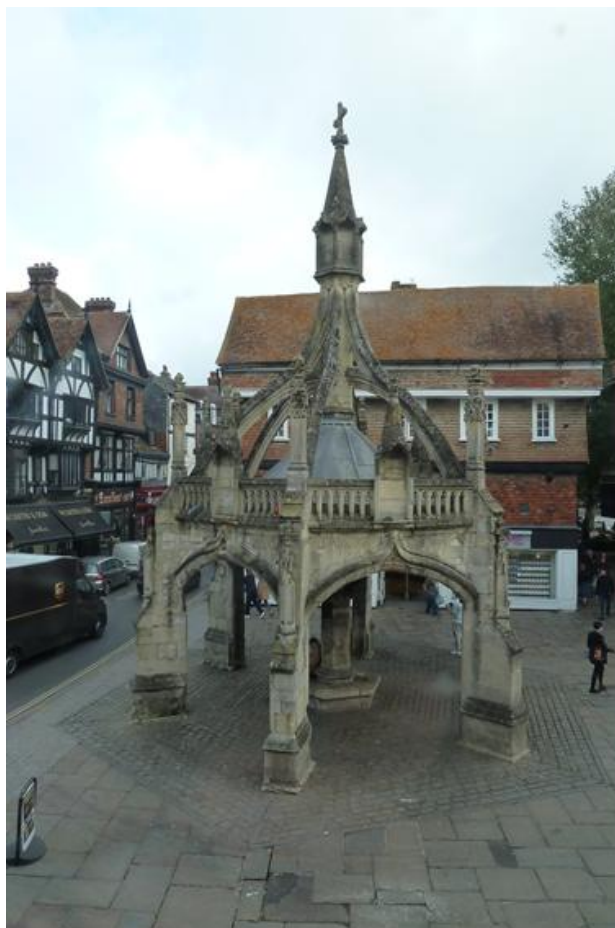
Fig 5: Poultry Cross, 2017, general extent of visibility of roof.

As a result of the asset transfer of the monument, In 2017 the architect was commissioned by Salisbury City Council to undertake a brief condition survey of the whole structure, from ground level. It was not possible to access or view the roof to assess its general condition from above, although distant views were possible from the first floor of neighbouring commercial properties.

Despite the roof being inaccessible for inspection, water staining on the timber boarding to the underside was noted, along with the caveat that significant and rapid decay could ensue if leaks were not remedied.

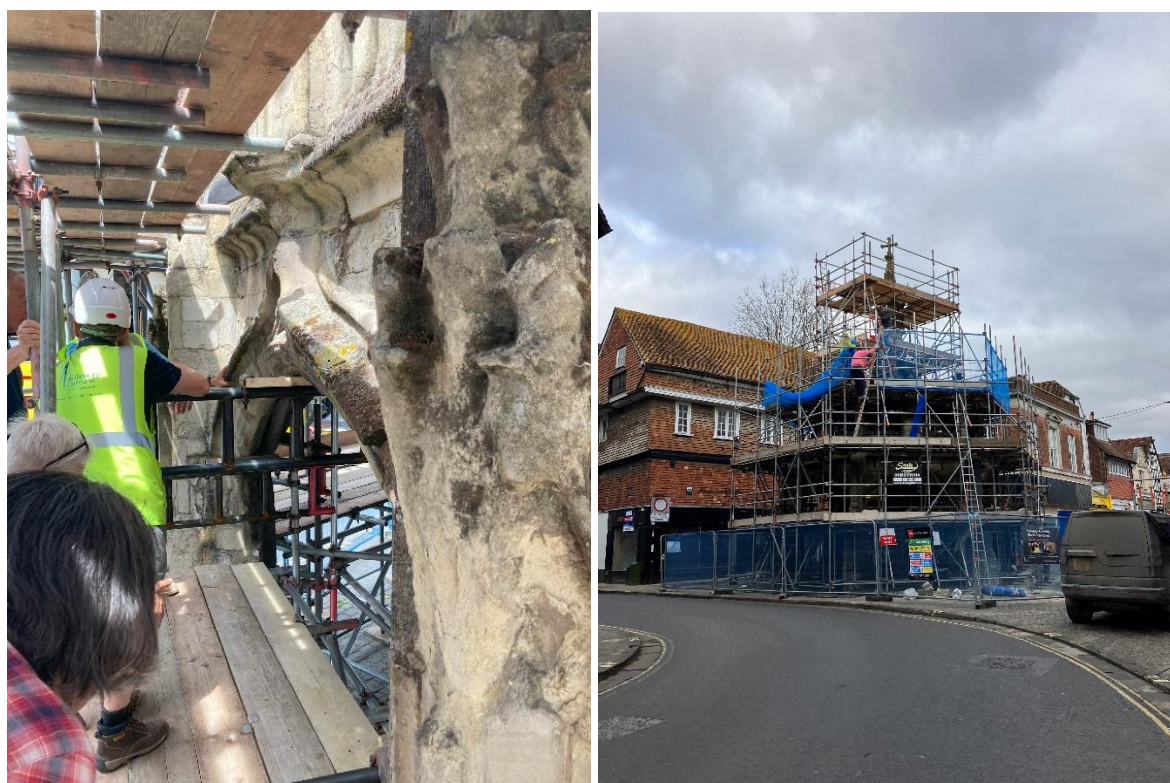
Fig 6 and 7 : Poultry Cross, 2022: Dense structural scaffold to facilitate masonry repairs prohibited access into the internal roof structure.

The 2022 report states clearly the limitations of this inspection – the vast structural scaffold was knitted through the stone structure; it was impossible to simultaneously inspect the timbers below the aged lead roof to ascertain their condition. It was again noted (as in the 2017 report) that sustained water damage to timber can accelerate decay substantially. We attempted to attribute very loose budget costs to various priority areas for repair in the 2022 report, but did not have a detailed understanding of the condition of the timber roof structure. In the knowledge that no repair or maintenance works has been recorded in the recent past, we could anticipate that it would be very likely that the condition would be rapidly deteriorating.

Whilst the scaffold provided advantageous (and unexpected) access to other areas beyond the buttress repair, its primary structural role in stabilising the structure precluded access to the underside of the roof. The architect was not appointed in the specification of repairs and, to my knowledge, no further structural surveys were carried out once the buttress repair was complete.

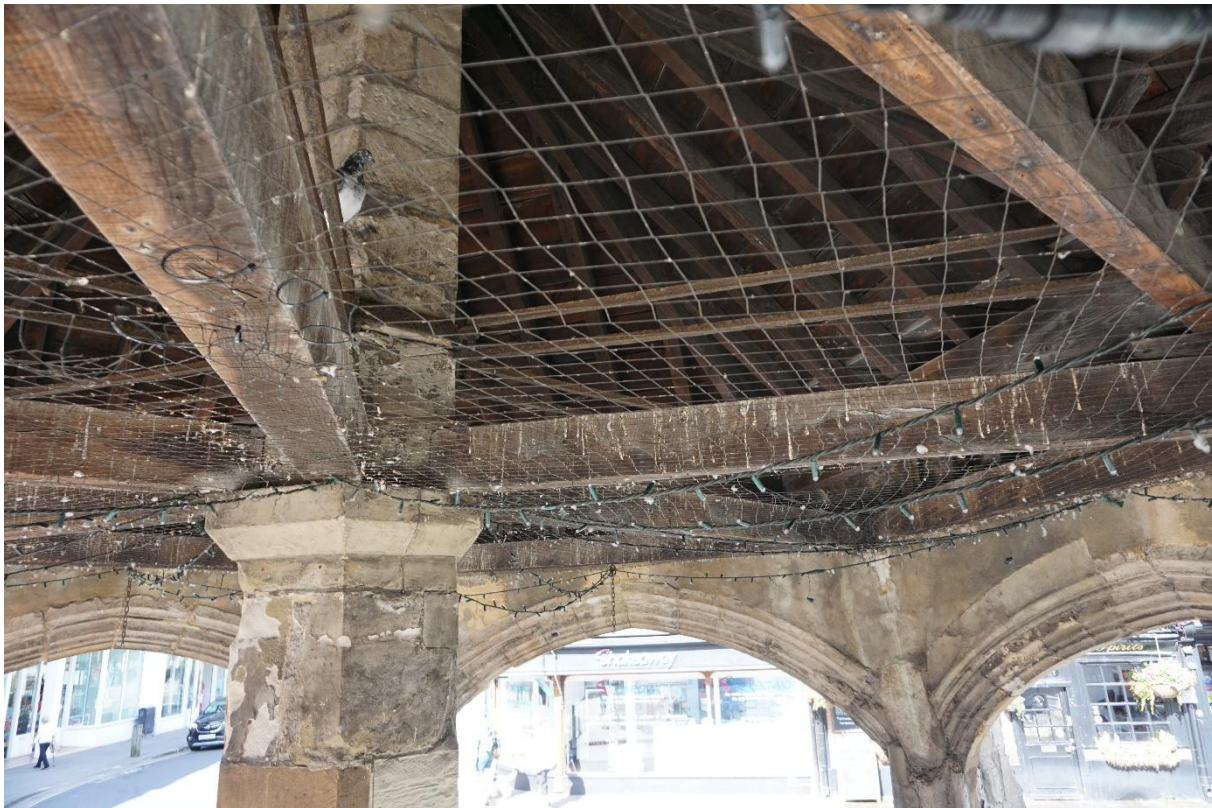
Fig 8: Poultry Cross, 2025: High level inspection of internal roof structure.

It is critical to prioritise roof repairs ahead of other conservation work to ensure that the roof is watertight. Internally, the exposed roof timbers are water-streaked and decayed, notably at bearing ends. Repairing the lead roof structure is therefore the highest priority item, as persistent water ingress will continue to cause further timber decay of the roof structure. On this basis, it is logical to start with a 'top-down' approach, addressing the roof and high-level masonry first and then subsequently, the masonry below.

Repairs to the roof structure and replacement of the lead coverings go hand-in-hand and form one project – to attempt to do it partially would be uneconomical and short-sighted. This represents a significant focus on the roof. This design work is now underway, although we will not know the full extent until we open up the lead roof.

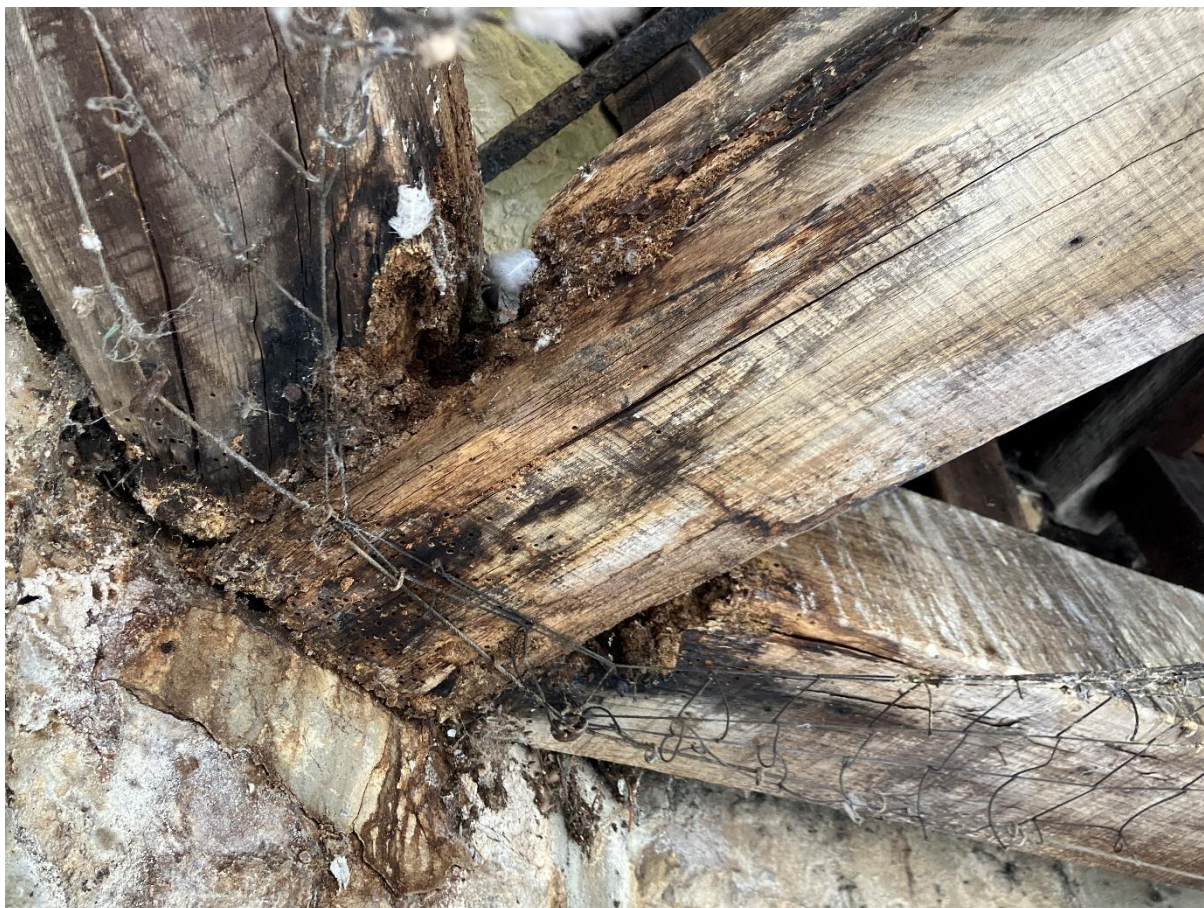
Fig 9: Poultry Cross, 2025: High level inspection of internal roof structure; significant decay at beam ends and junctions in timber structure.
