Repair Work to: The Poultry Cross

Salisbury City Council

Presentation to the City Council

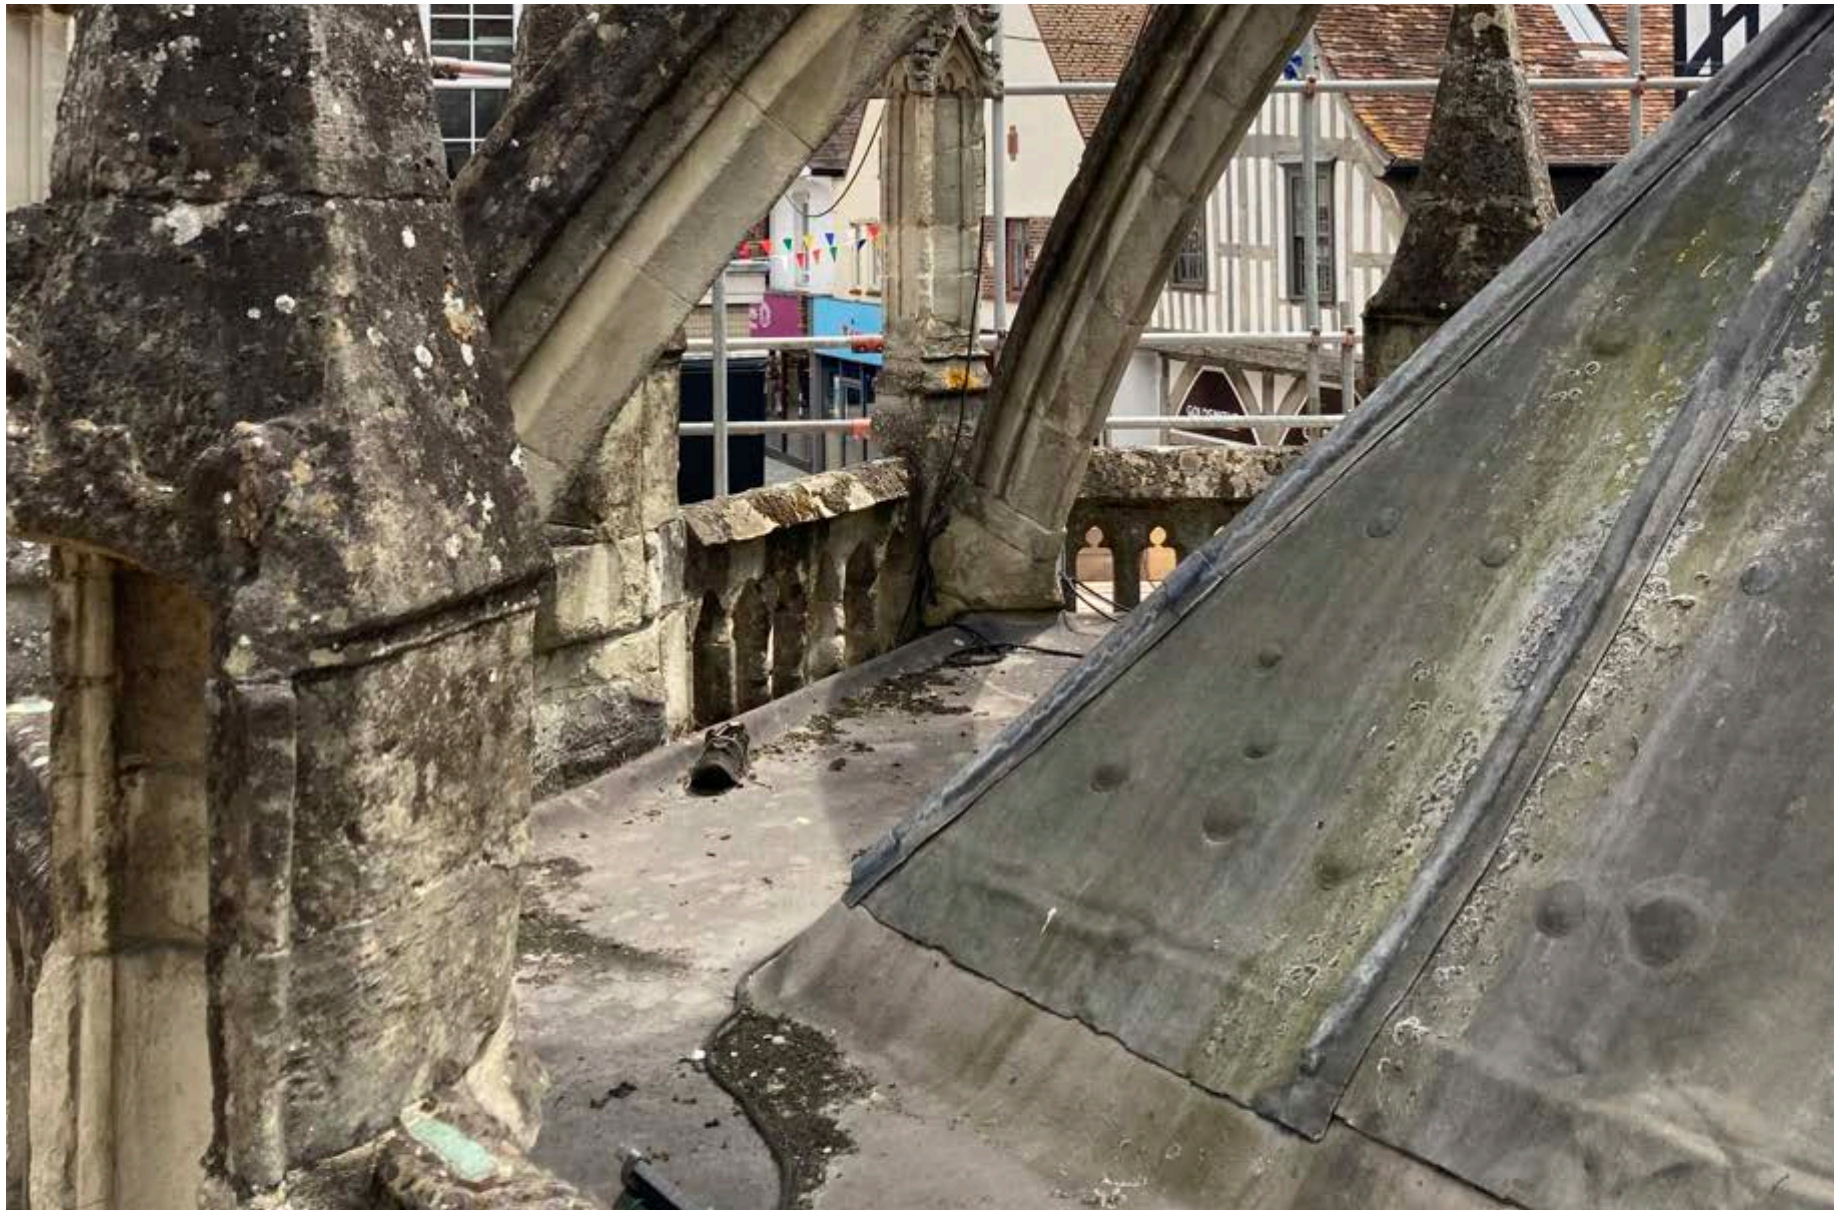
The Poultry Cross Today

- ★ Roof finishes in a poor condition
- ★ Water ingress evident
- ★ Poorly detailed, with cracking to the lead sheet

- ★ It is critical to prioritise roof repairs ahead of other conservation work to ensure that the roof is watertight.
- ★ Internally, the exposed roof timbers are water-streaked and decayed, notably at bearing ends.
- ★ Repairing the lead roof structure is therefore the highest priority item, as persistent water ingress will continue to cause further timber decay of the roof structure.

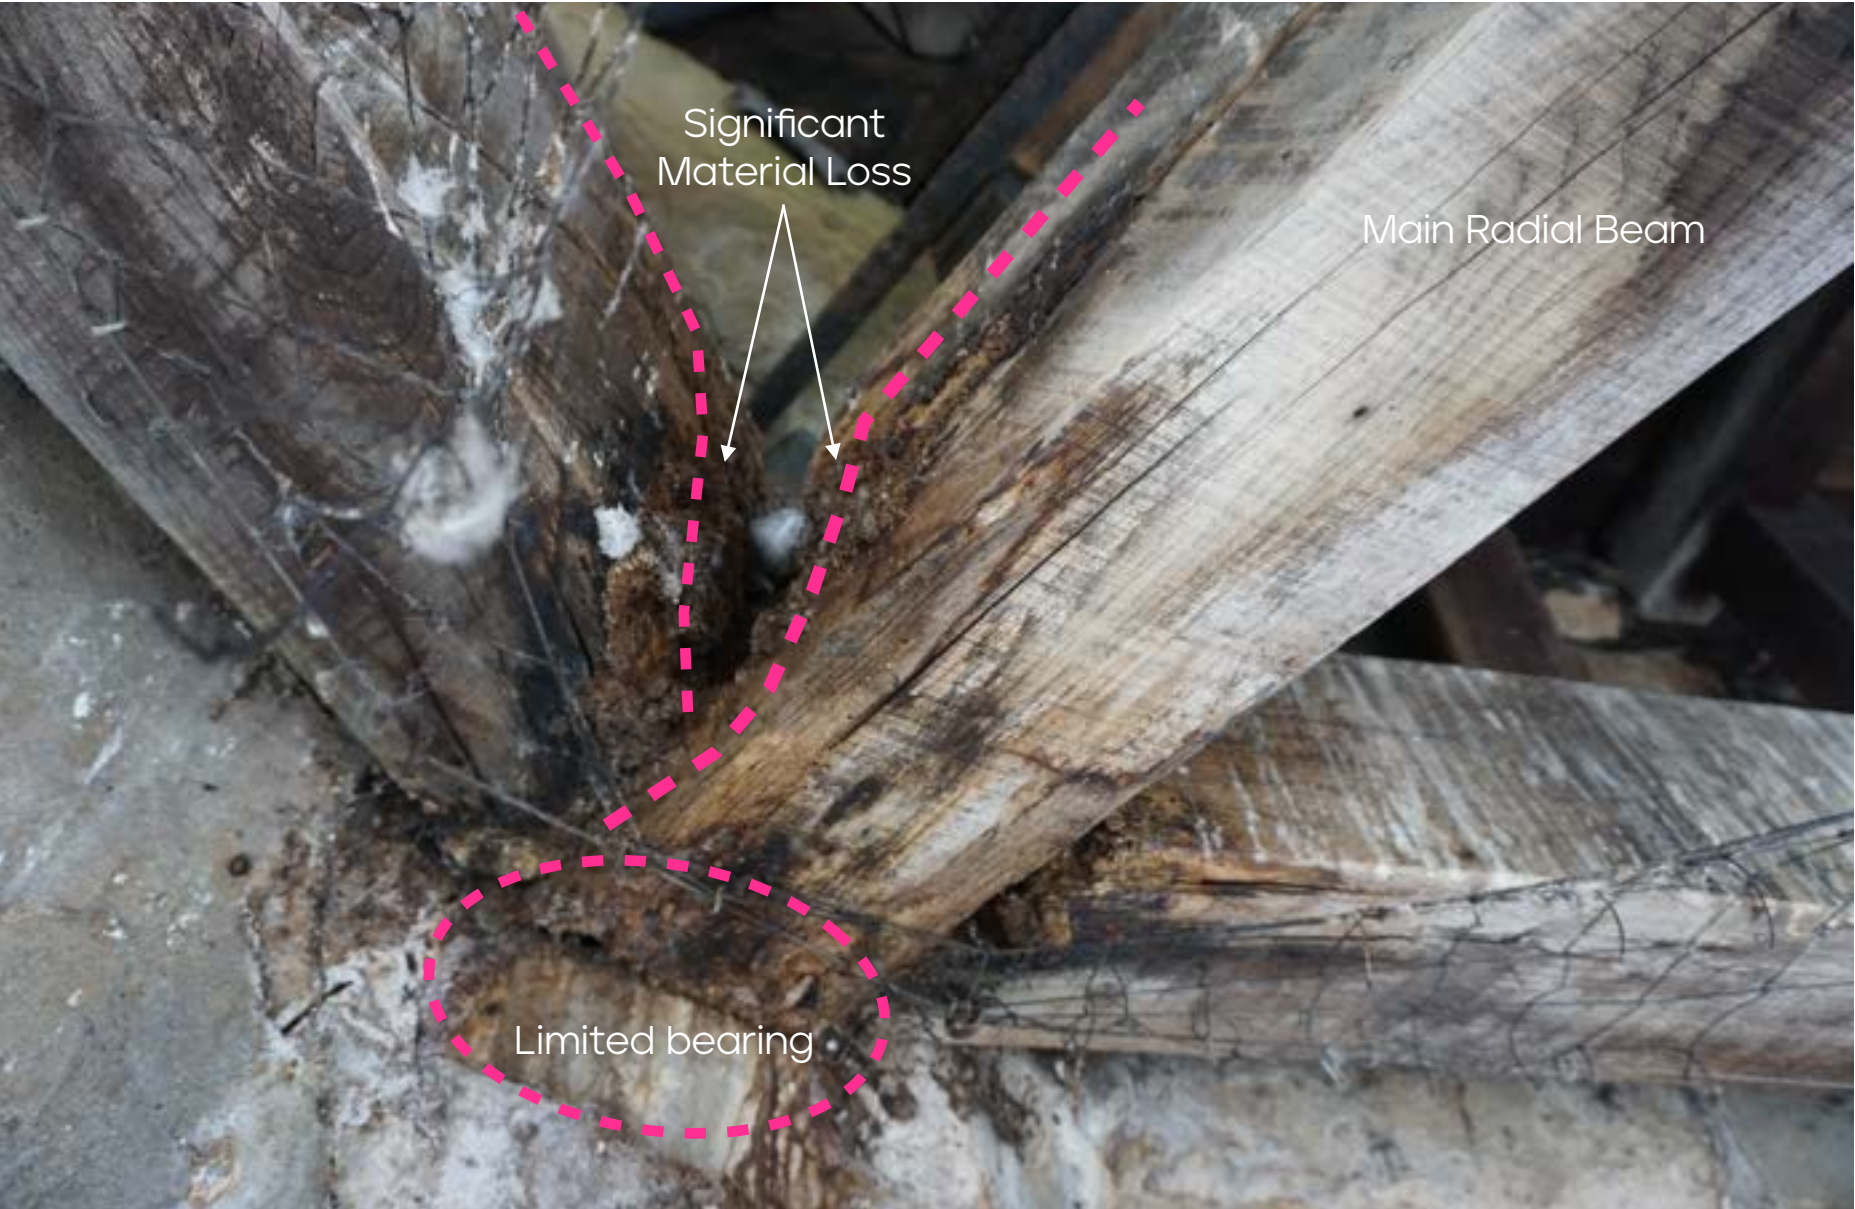
Significant timber decay to primary roof structure

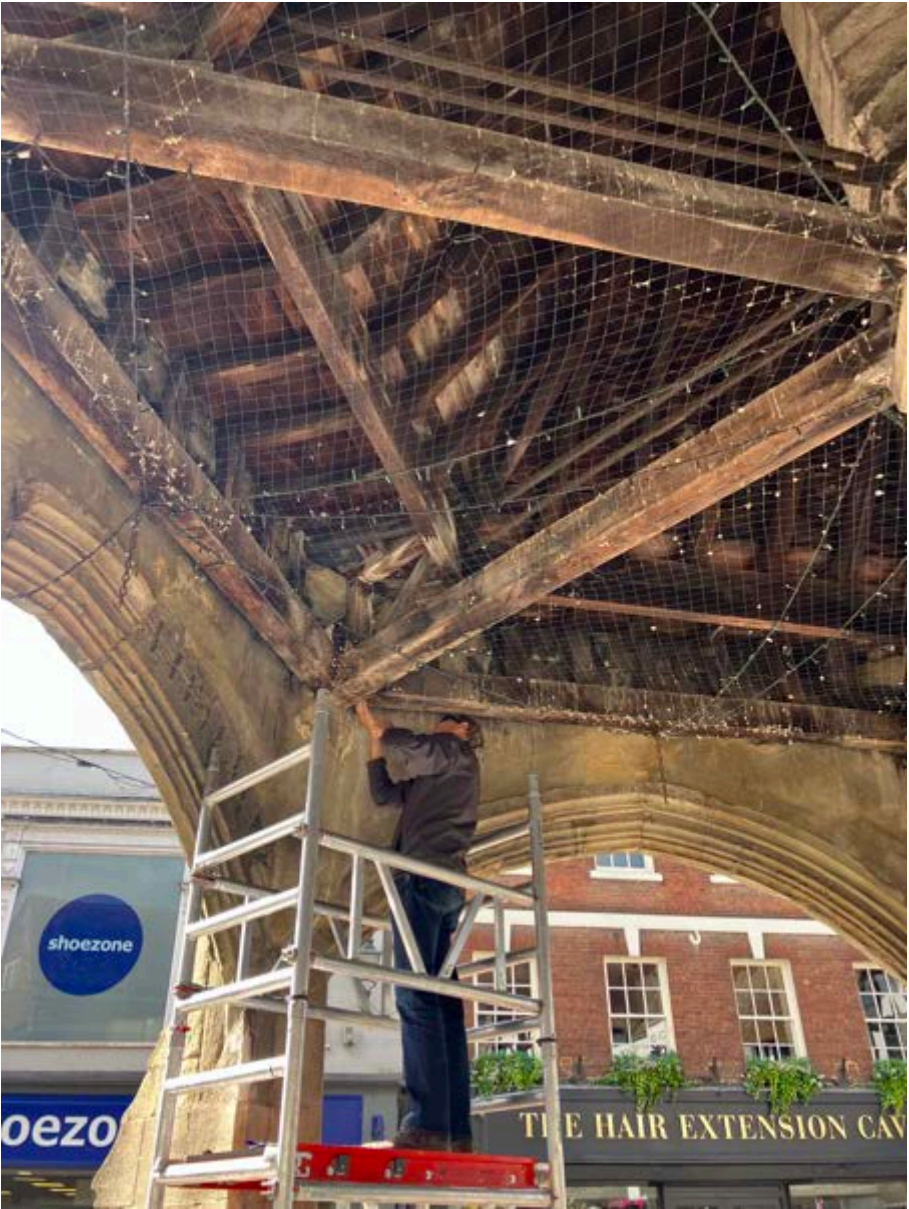
Water ingress to majority timber and boards

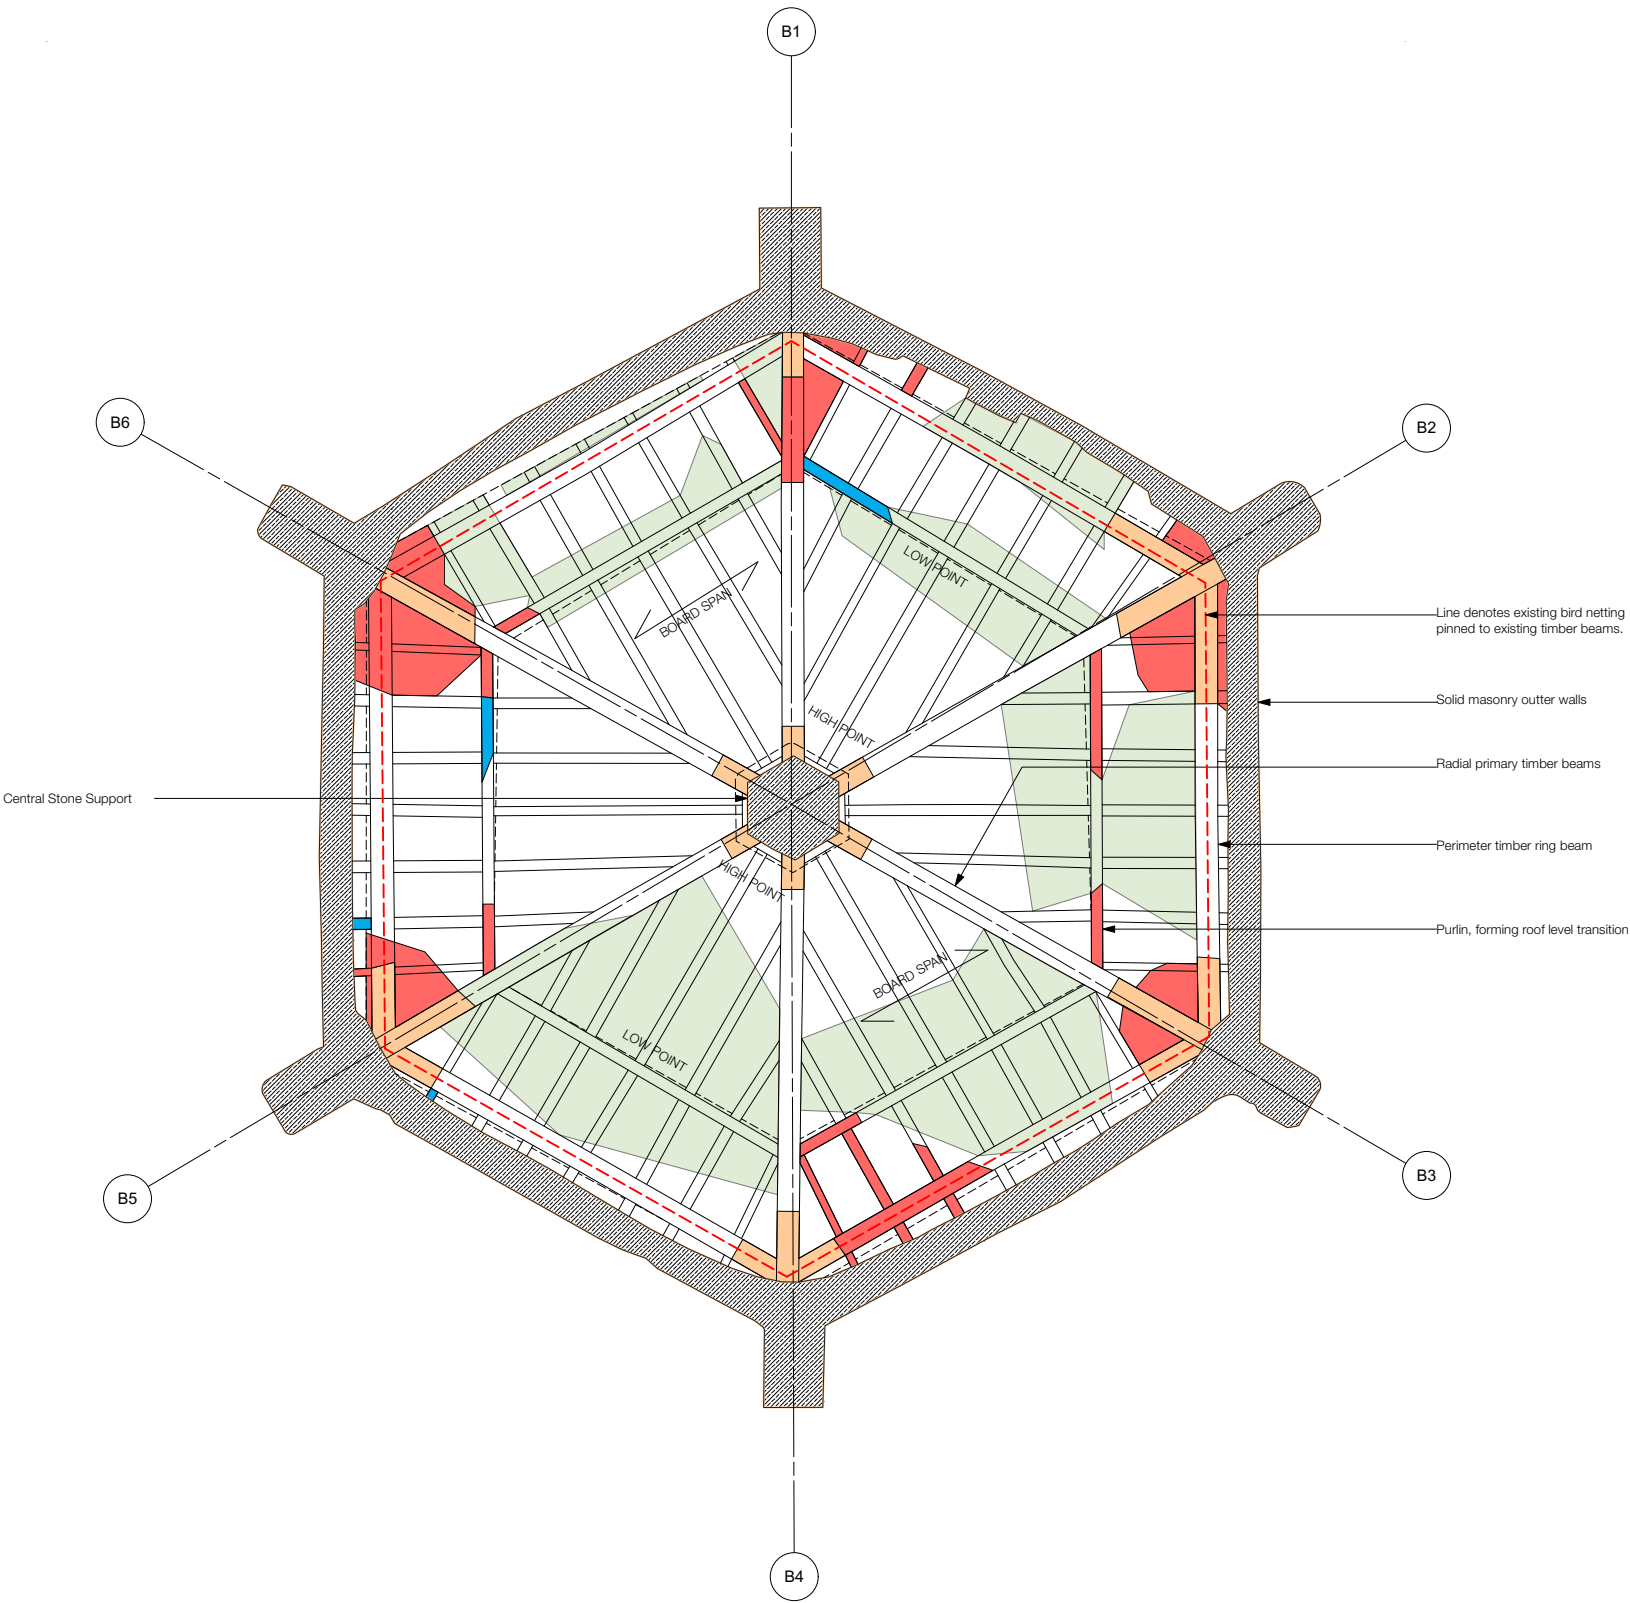
Loop Architects scheduling drawing

- Red = Significant Timber Decay
- Orange = Decay to structural timbers
- Green = Signs of water damage

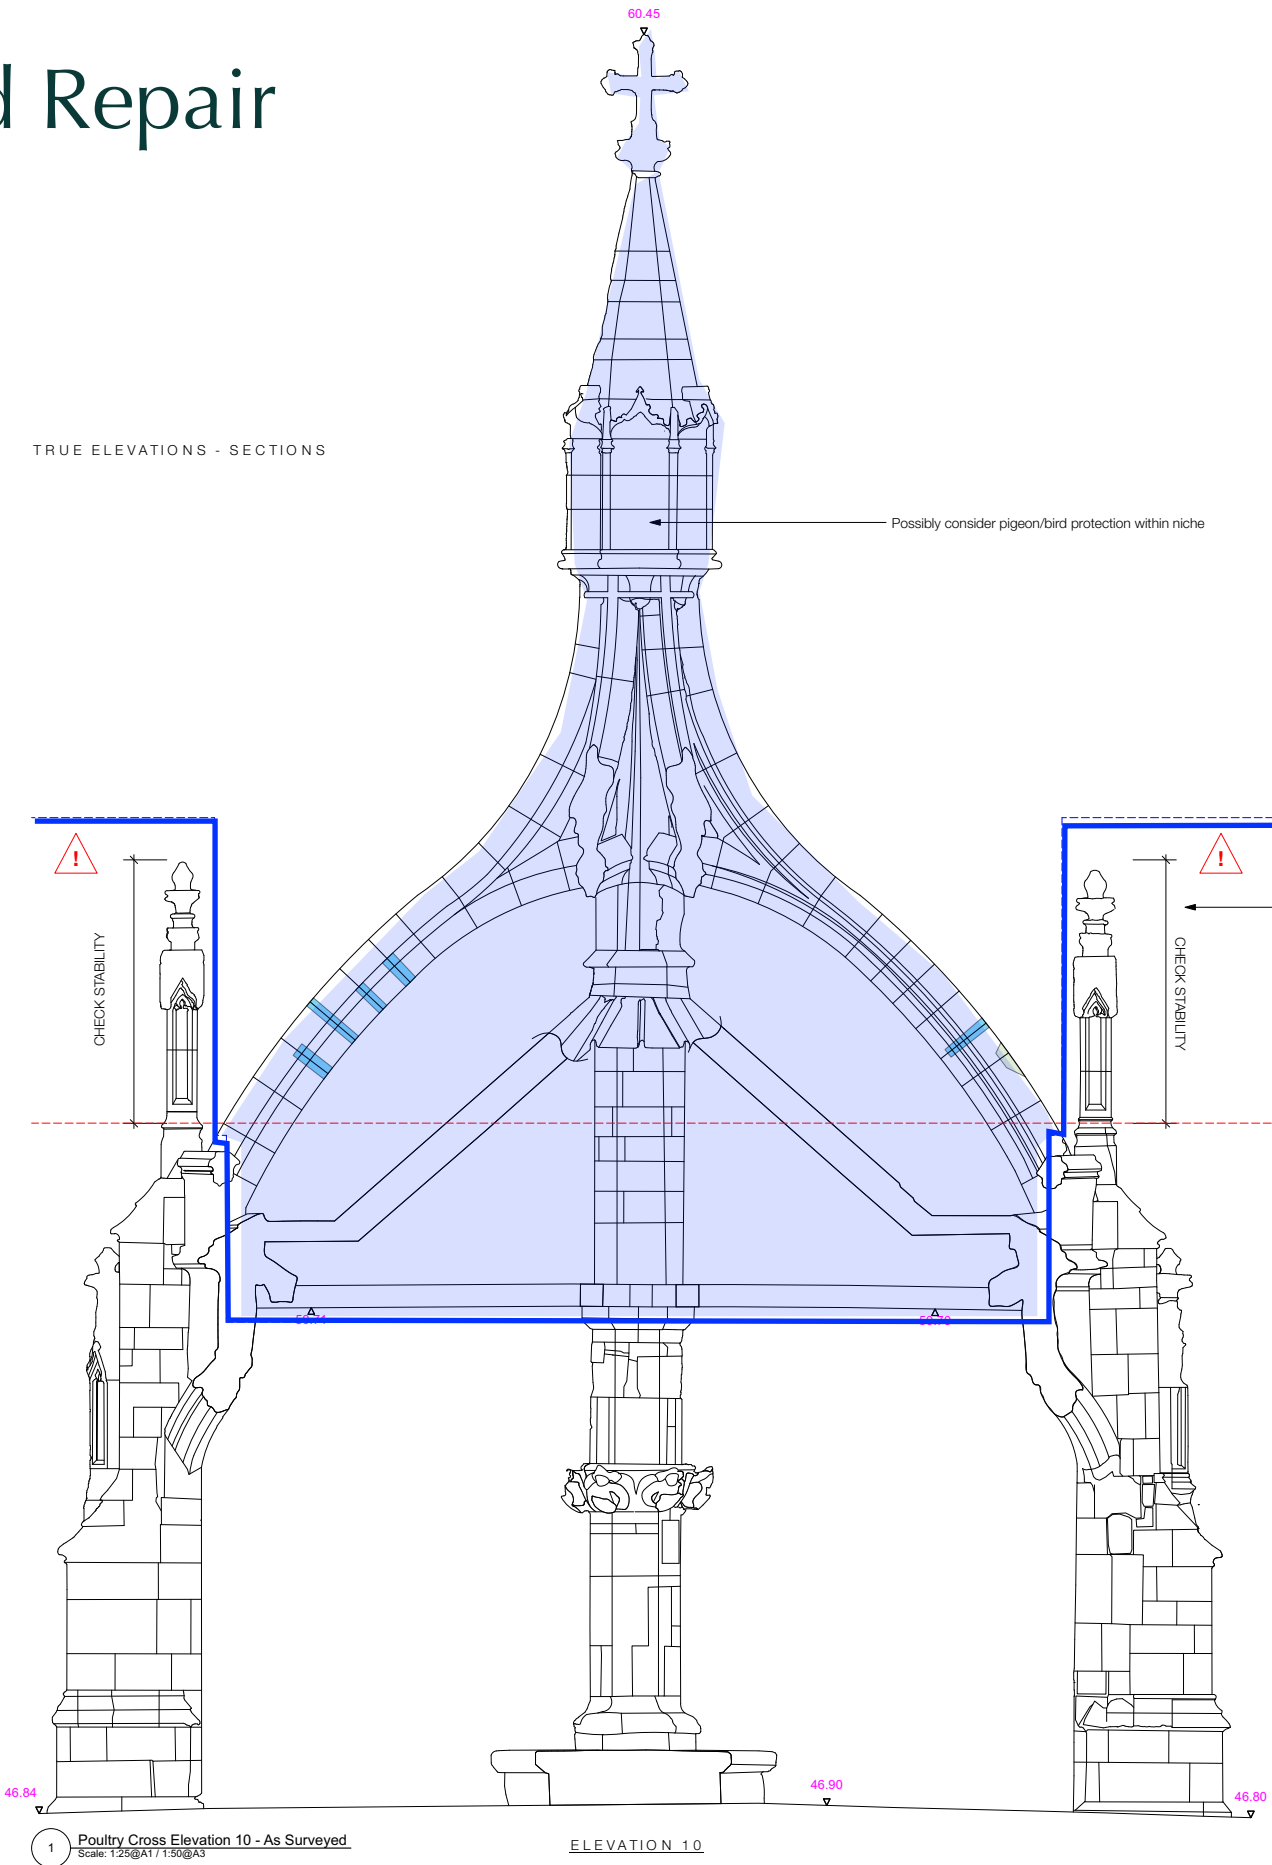
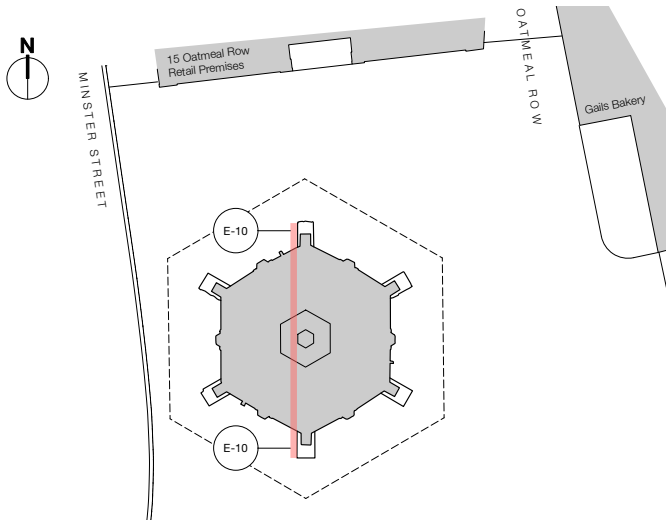
1 Poultry Cross Elevation 10 - As Surveyed
Scale: 1:25@A1 1:50@A3

- Significant Timber Decay
- Significant Timber Water Damage (Damp)
- Timber Splitting and Defects
- Significant Decay to Primary Structure (Ring/Radial Beams)
- Denotes existing Lead sheet roof finish
- Denotes existing asphalt/bitumen membrane
- Denotes Buttress Number

- ROOF COVERINGS & STRUCTURAL REPAIRS
- VICTORIAN MASONRY - 'CROWN'
- REAR OF PARAPET/ROOF JUNCTION ABUTMENT
- STONEMWORK WITHIN ROOF AREA

- ★ Roof coverings & structural repairs
- ★ Victorian masonry 'Crown'
- ★ Rear of parapet/roof junction abutment
- ★ Stonework within the roof area
