SALISBURY  
CITY COUNCIL

# WYNDHAM PARK WALLS

## SOLUTION PROPOSAL

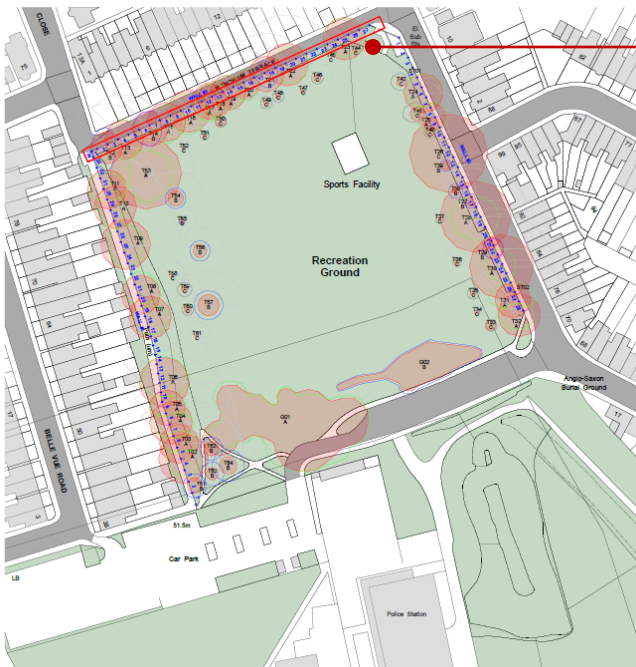
PLN 01 Location Plan  
1:500

All three walls in Wyndham Park are in a poor state of repair but Wall #3, Wyndham Terrace, is a cause for concern due to the amount of ‘lean’ recorded. The wall, approximately 2.5m in height, is in a dangerous condition.

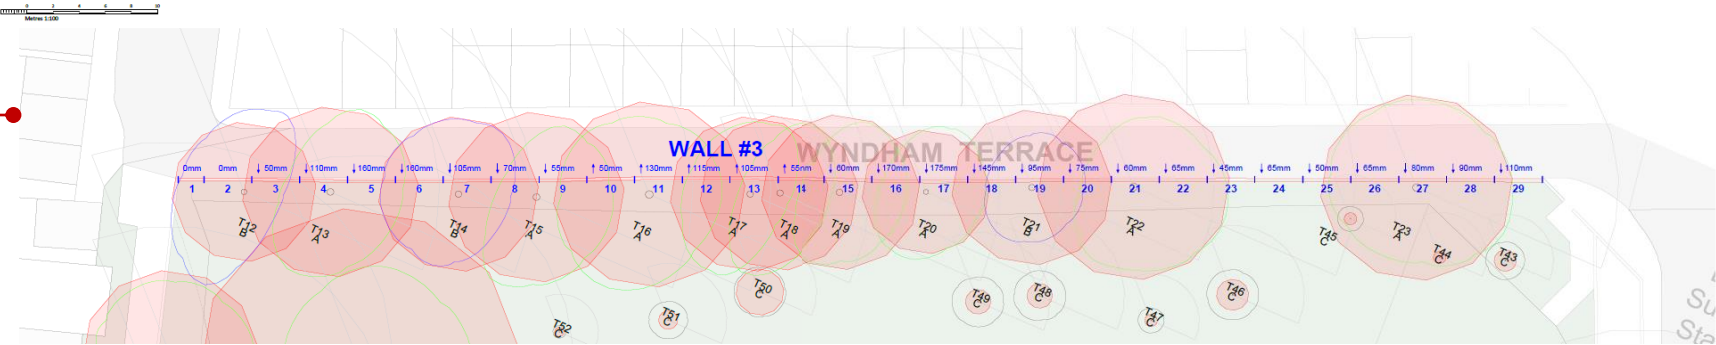
Wall #3 Bay 3

The causes of the deformation of these walls is the close proximity of the mature trees (1.0m) - refer to the images to the right. The tree roots have damaged the wall footings, passing under the wall in some instances and in doing so, has had a destabilising effect on the walls.

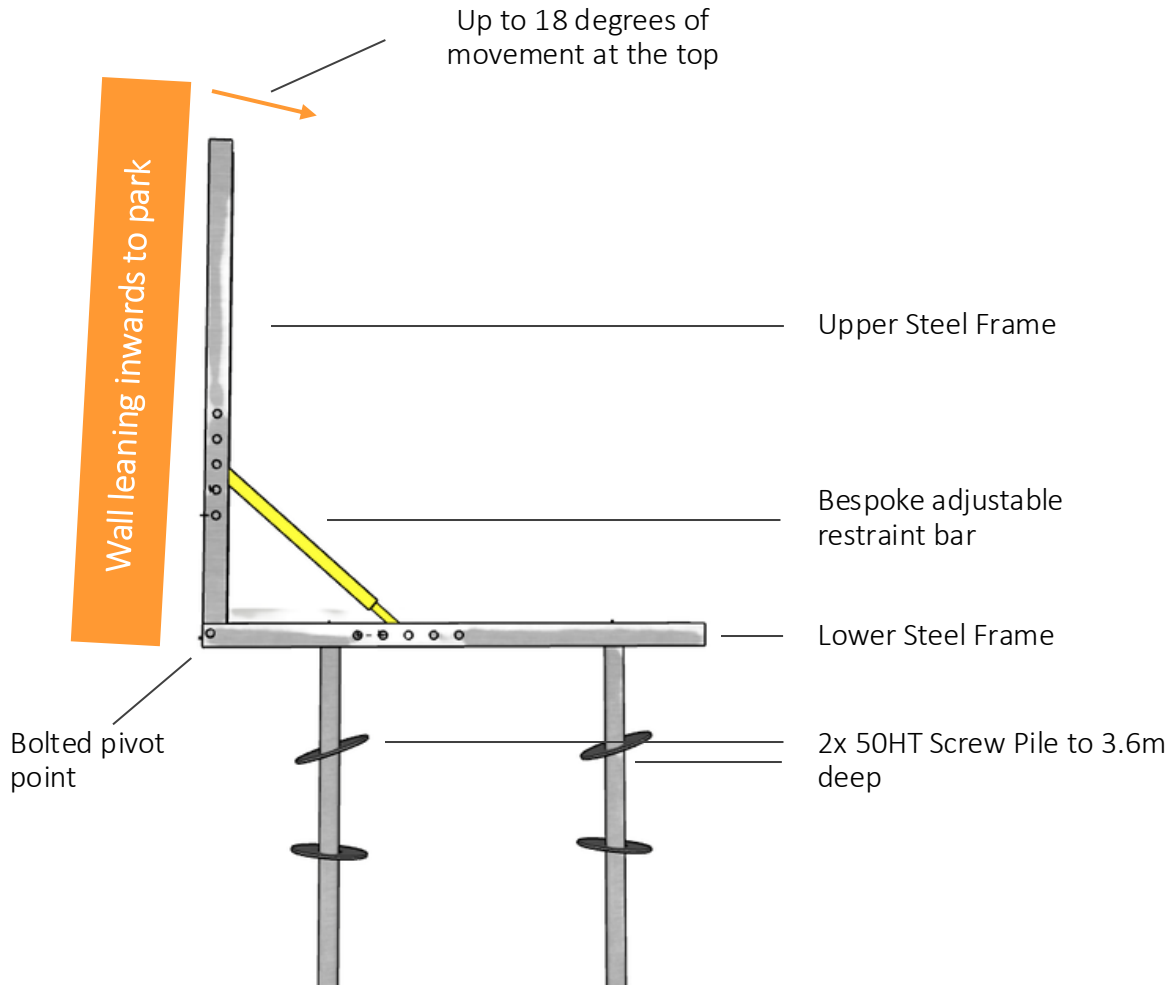
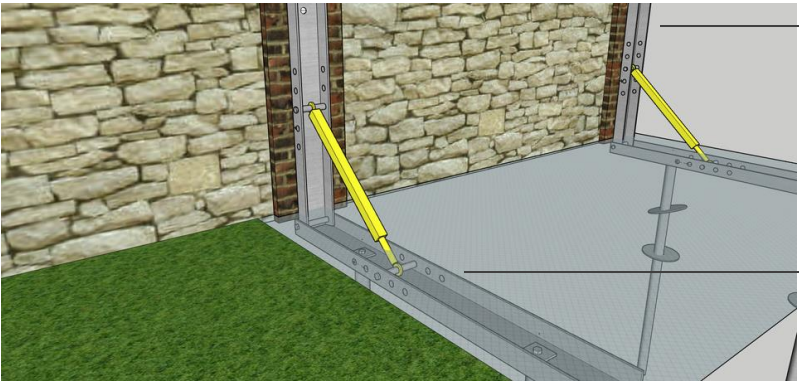
Bolted connection at base and chemically bolted into wall in two locations.

Bolted connection nearest wall and predrilled holes allowing restraining bar to change position.

Ground element has been removed to illustrate that the lower frame will be attached to the top of the screw piles, positioned below-ground level. Soil is replaced over the frame once the solution is in place.

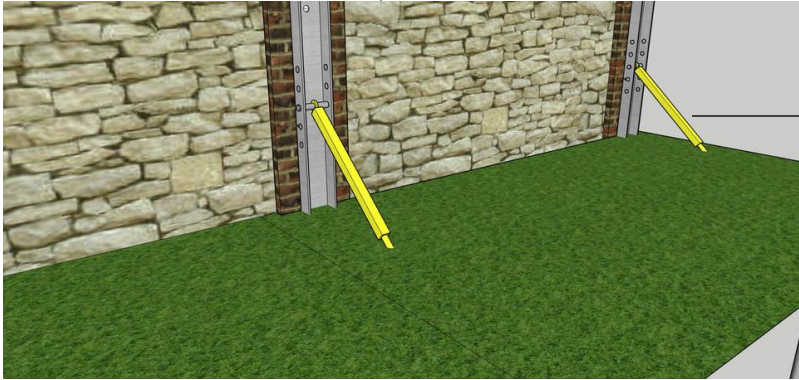
Adjustment on site depending on the pitch of the wall. Hi visibility paint for public awareness.

CAD visual showing how ground will look once grass has regrown
