SALISBURY CITY COUNCIL

Subject : Wyndham Park Wall
Committee : Environment & Climate Committee
Date : 9 Oct 2023
Author : Marc Read, Environmental Services Manager

2. Wyndham Park Open Space Wall – Condition Report

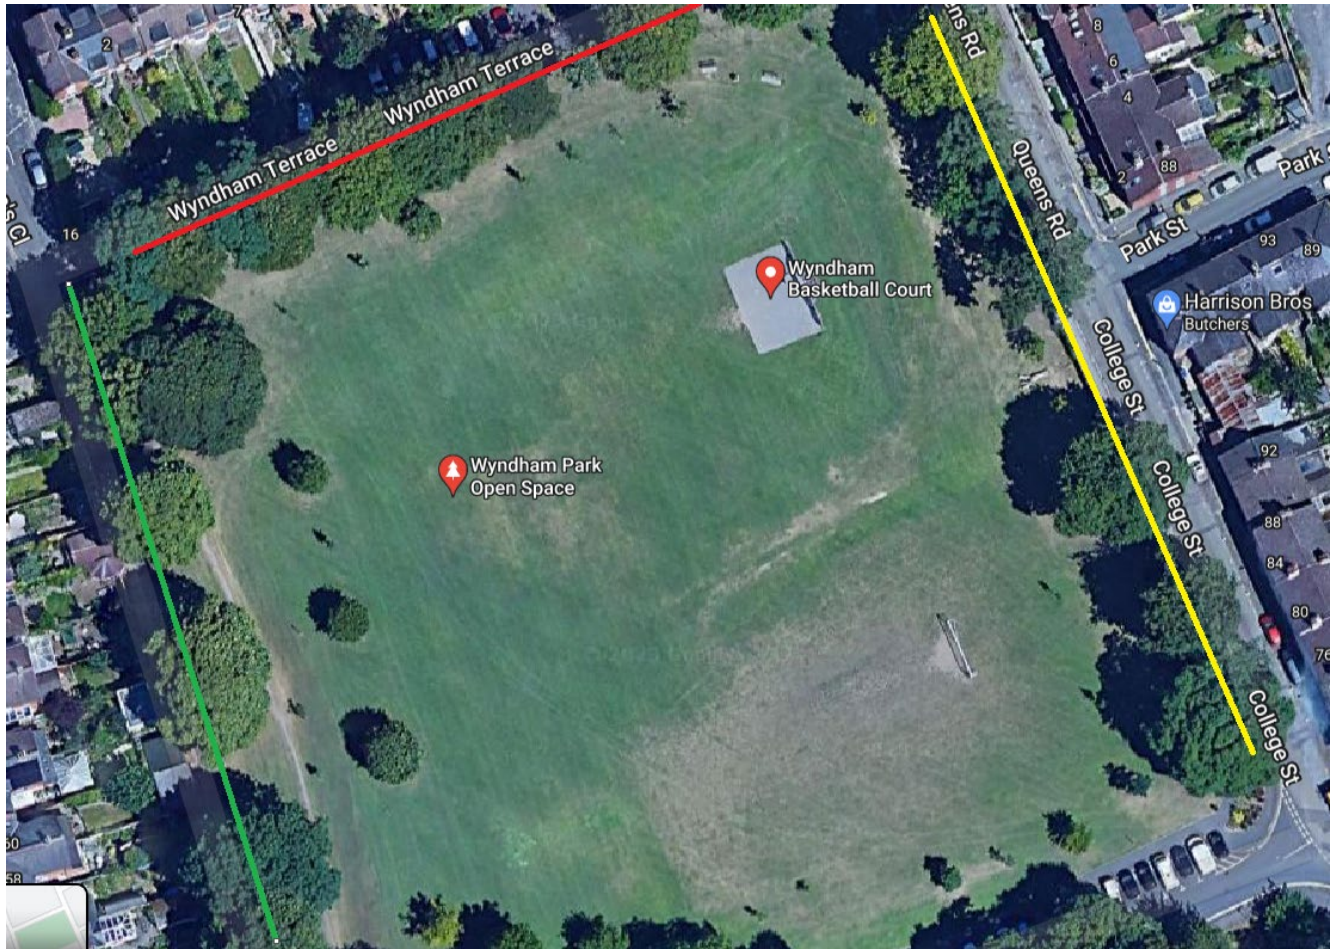
2.5. For the purpose of this report the wall itself is split into 3 sections:

- Wall 1 – Swaynes Close (shown by the green line on the map below)
- Wall 2 – College Street/Queens Road (shown by the yellow line on the map below)
- Wall 3 - Wyndham Terrace (shown by the red line on the map below)

- 2.6. The walls are free standing although the soil, on the Park side, is higher than on the road side in most cases – maximum measured being 0.75m for wall 1, 0.44m for wall 2 and 0.42m for wall 3.

- 2.8. Brick Piers, 350 deep x 375 wide, positioned at approx. 3.7m centres, support the main wall structure. The approximate length of each wall is:
- Wall 1 – 130m

- Wall 2 – 96m
 - Wall 3 – 105m
- 2.9. The walls in total length are approximately 400m/quarter of a mile.
- 2.10. The condition of all three walls has been described by the structural engineer as very poor, and more concerning, is the degree at which a significant number of the wall panels are leaning out of the vertical.
